Macondo

T H E G U L F O I L D I S A S T E R

Chief Counsel's Report | 2011

National Commission on the BP Deepwater Horizon Oil Spill and Offshore Drilling

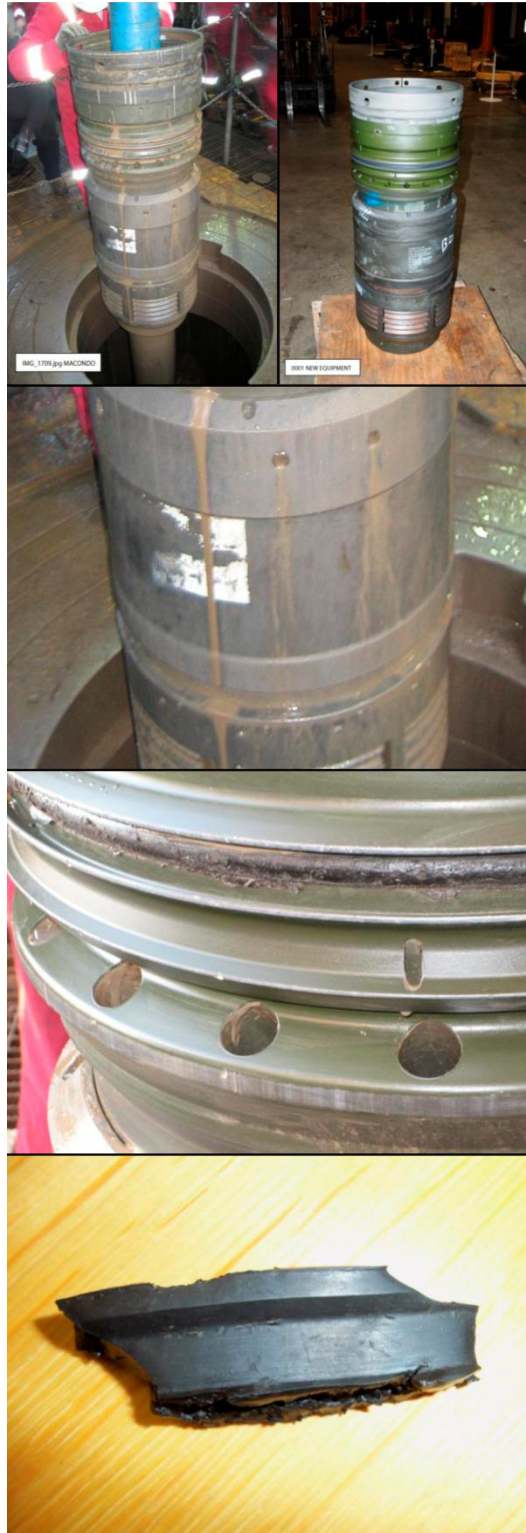
- Figure 4.1.4. Exterior of the Macondo production casing hanger and seal assembly. The outside surfaces of the Macondo casing hanger and seal assembly show no damage (left). They have no erosion-induced channels. Instead, they resemble the condition of brand-new equipment (right).

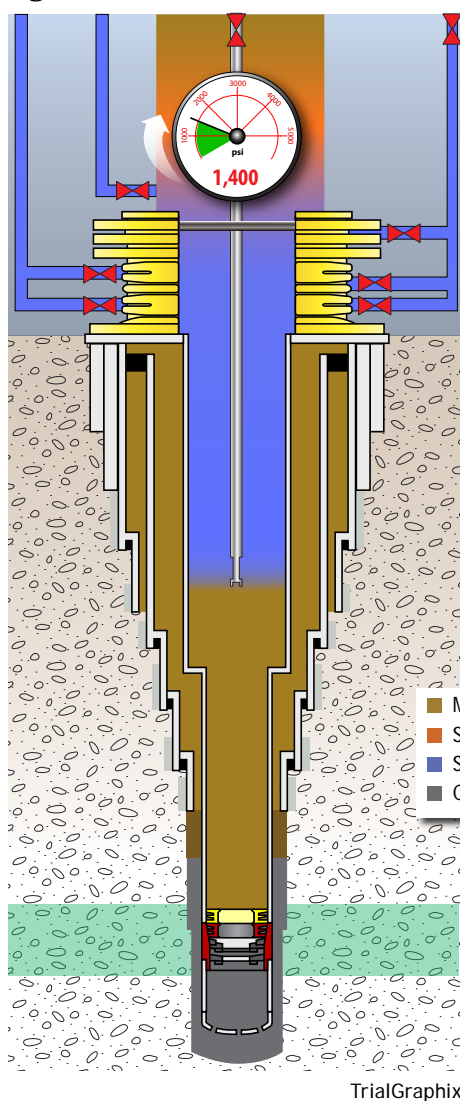
Figure 4.6.7. First test failure.

During the first negative pressure test, the crew repeatedly bled the drill pipe pressure down to 0 psi. However, more fluids bled than expected, and the drill pipe pressure repeatedly increased. After the last bleed, the drill pipe pressure rose from 0 to 1,400 psi, a clear failure.

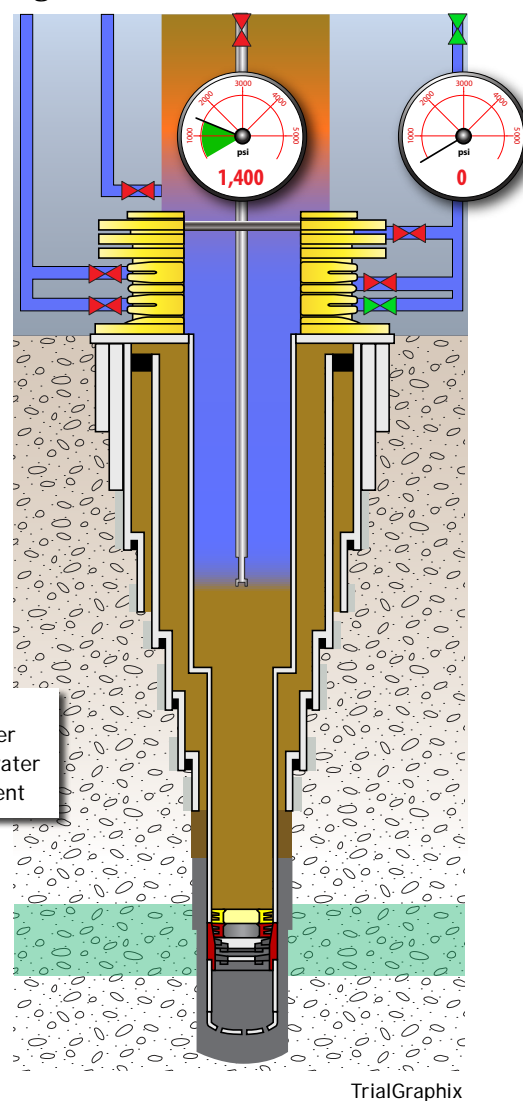
Figure 4.6.8. Second test failure.

During the second negative pressure test, the crew bled off the pressure in the kill line, rather than the drill pipe. The crew observed no excessive flow or pressure buildup on the kill line. The well site leaders and rig crew decided this was a successful test. But they had never accounted for the pressure on the drill pipe, which remained at 1,400 psi throughout the second test.

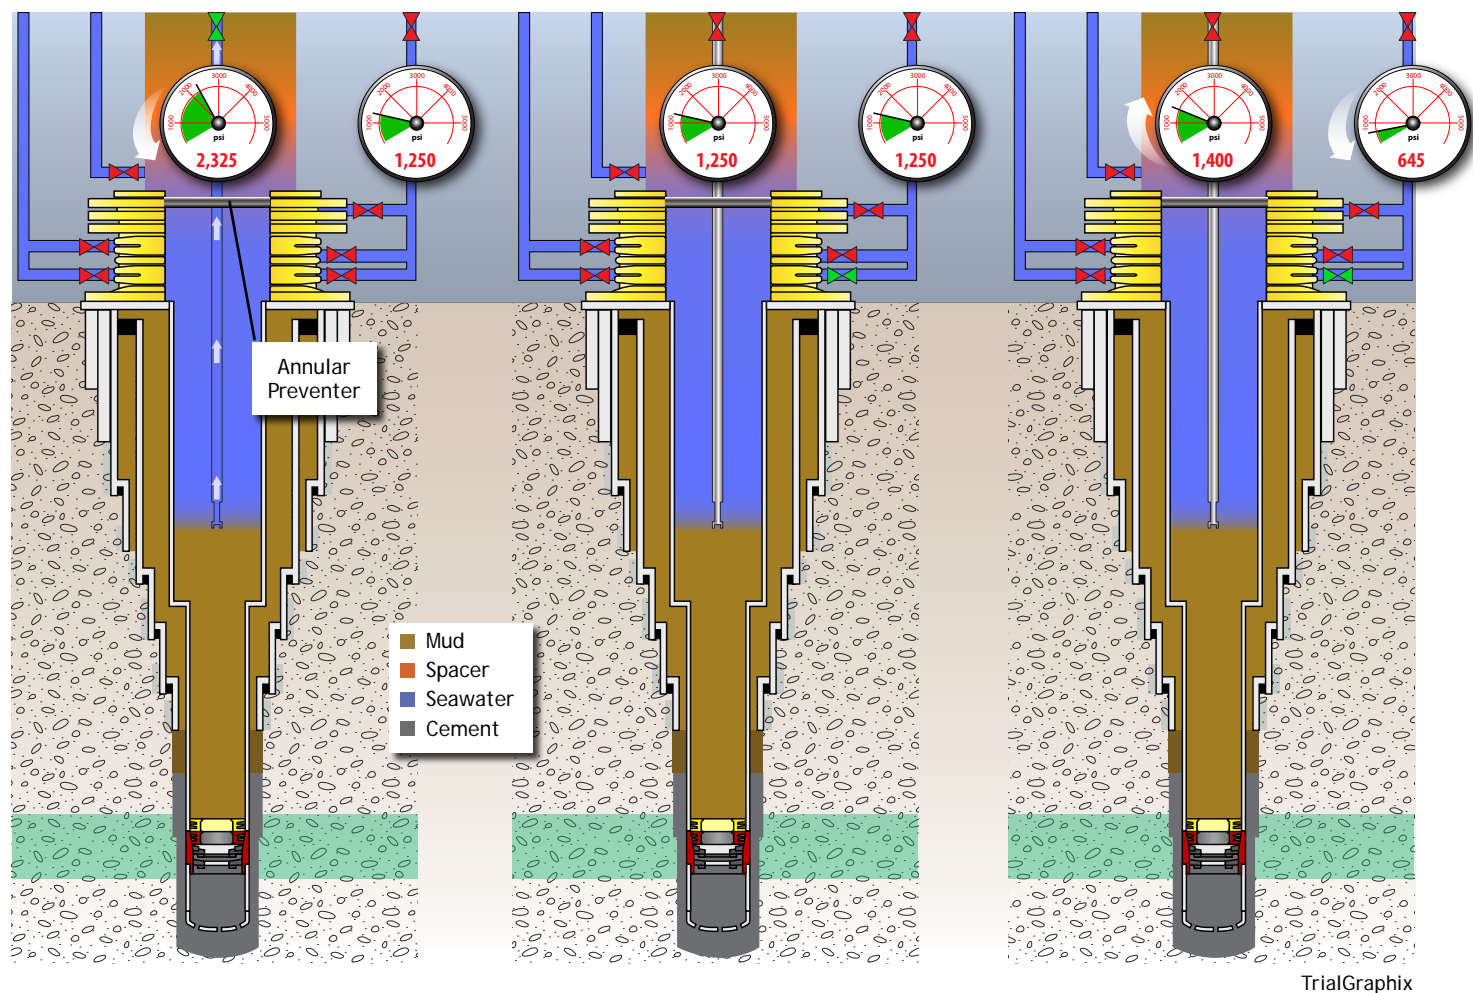
Figure 4.6.12. 4:55 p.m.

After the annular preventer was closed (left) the crew bled down the pressure in the drill pipe to equalize its pressure with the pressure in the kill line. Because both the drill pipe and the kill line go to the same vessel, when the valve connecting the kill line to the BOP is opened, the pressures should remain equal (middle). Instead, when the valve was opened, the pressures diverged (right).

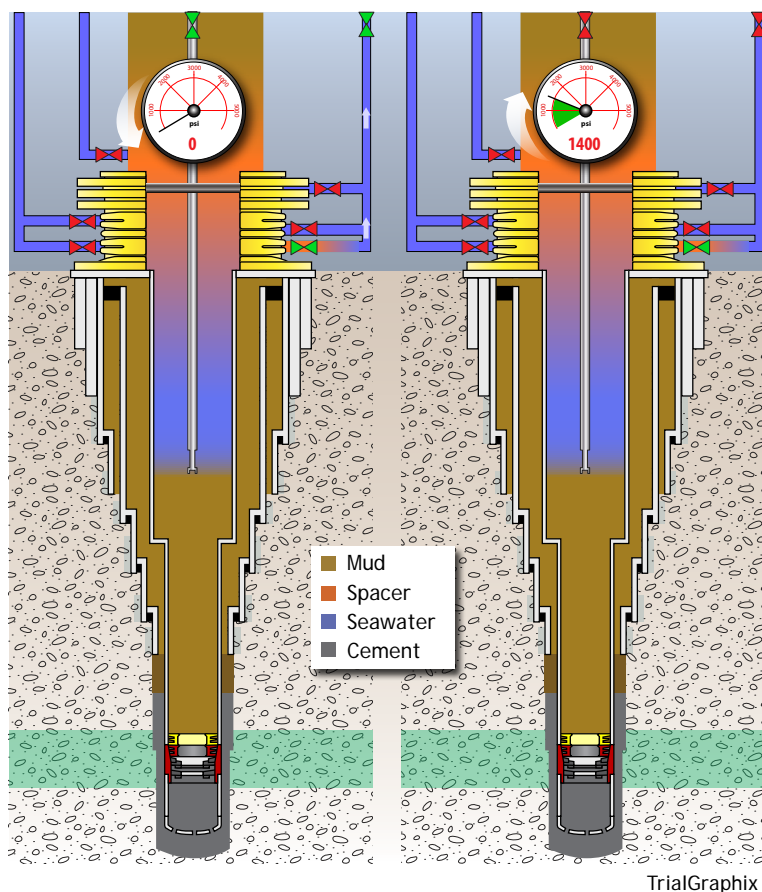
Figure 4.6.16. 5:53 p.m.

The rig crew bled drill pipe pressure down for a third time, this time through the kill line. Witnesses reported that three to 15 barrels were returned as the drill pipe reached 0 psi (left). When the drill pipe was shut, the drill pipe pressure rose to 1,400 psi. According to BP witnesses, the Transocean rig crew attributed this rise to a “bladder effect.” A 15-barrel return would have been excessive, and the rise of drill pipe pressure to 1,400 psi was a clear sign that the negative pressure test had failed (right).

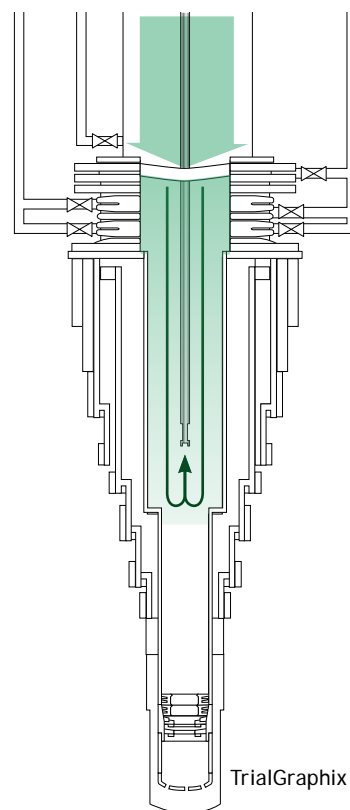
Figure 4.6.17

Bladder Effect. This figure represents the Chief Counsel's team's understanding of the "bladder effect" theory that supposedly explained the elevated pressure on the drill pipe. The "bladder effect" explanation contends that heavy fluids (mud and spacer) displaced to the riser were exerting force on the annular preventer from above, which in turn communicated pressure into the well. The Chief Counsel's team found no evidence to support this theory.

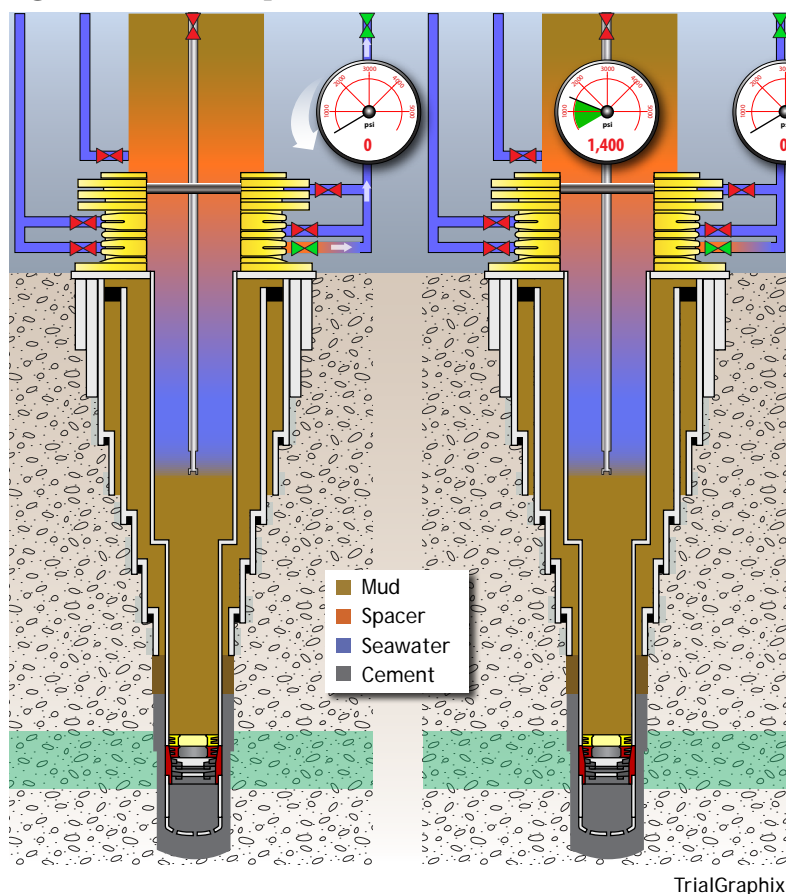
Figure 4.6.18. 6:40 p.m.

The rig crew conducted a negative pressure test on the kill line. The rig crew reduced the pressure on the kill line to 0 psi, bleeding an insignificant amount of water (left). No flow or pressure buildup was observed on the kill line, which on its own would have been a successful negative pressure test. However, the 1,400 psi on the drill pipe remained and was never properly accounted for (right).

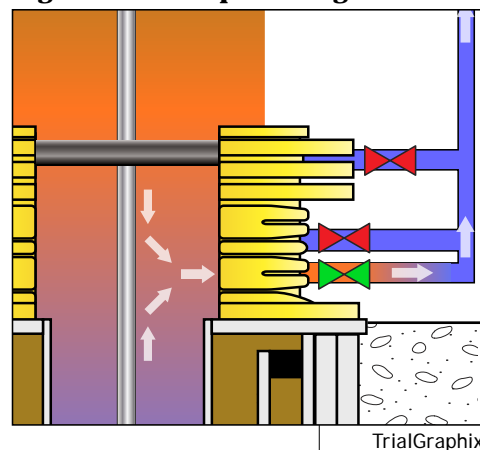
Figure 4.6.19. Spacer migration.

Leftover lost circulation material used as spacer for the negative pressure test could have migrated into the kill line during bleeds.

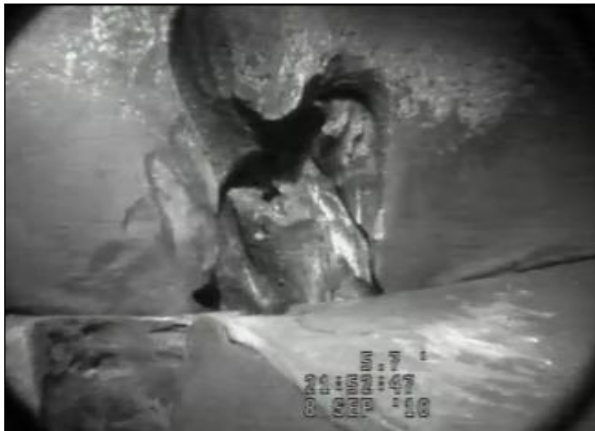
Figure 4.9.9. Erosion in the BOP.

Erosion above the blind shear ram on the BOP's kill side.
