Macondo

T H E G U L F O I L D I S A S T E R

Chief Counsel's Report | 2011

National Commission on the BP Deepwater Horizon Oil Spill and Offshore Drilling

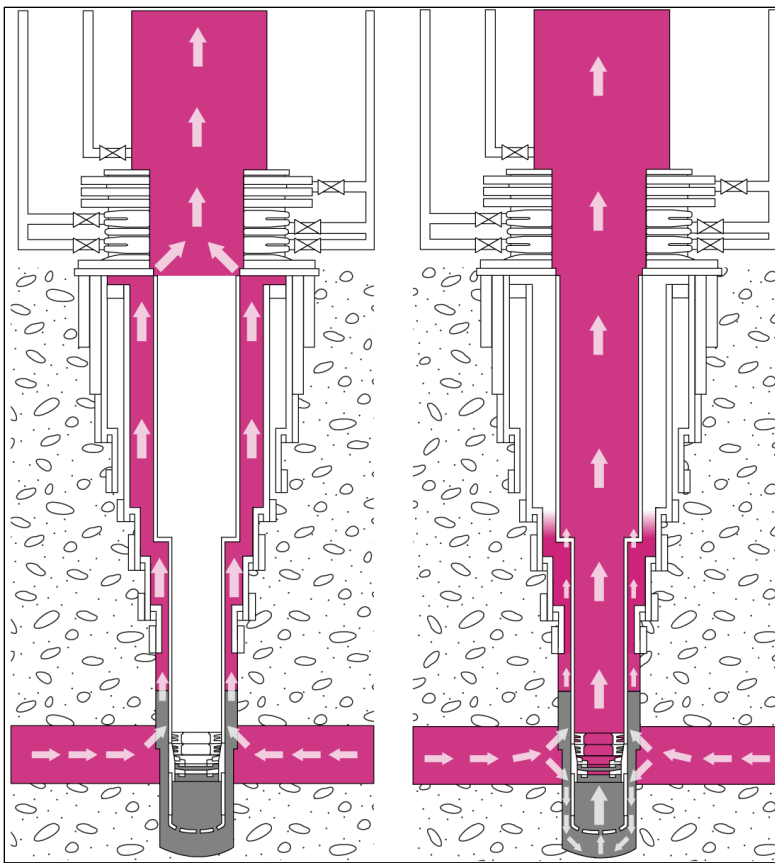
Figure 4.1.1. Possible flow paths for hydrocarbons.

Hydrocarbons can reach the surface by traveling up the annulus and through the seal assembly (left). Hydrocarbons can also enter and migrate up the inside of the production casing, through a number of possible flow paths (right).

The Chief Counsel's team finds that hydrocarbons came to the surface by traveling through the inside of the production casing, as seen on the right side of Figure 4.1.1. It is almost certain that hydrocarbons entered the production casing because of a failure of the shoe track cement. However, the Chief Counsel's team cannot entirely rule out the possibility that hydrocarbons may have entered the production casing from the annulus through a breach in the production casing somewhere near the bottom of the casing.

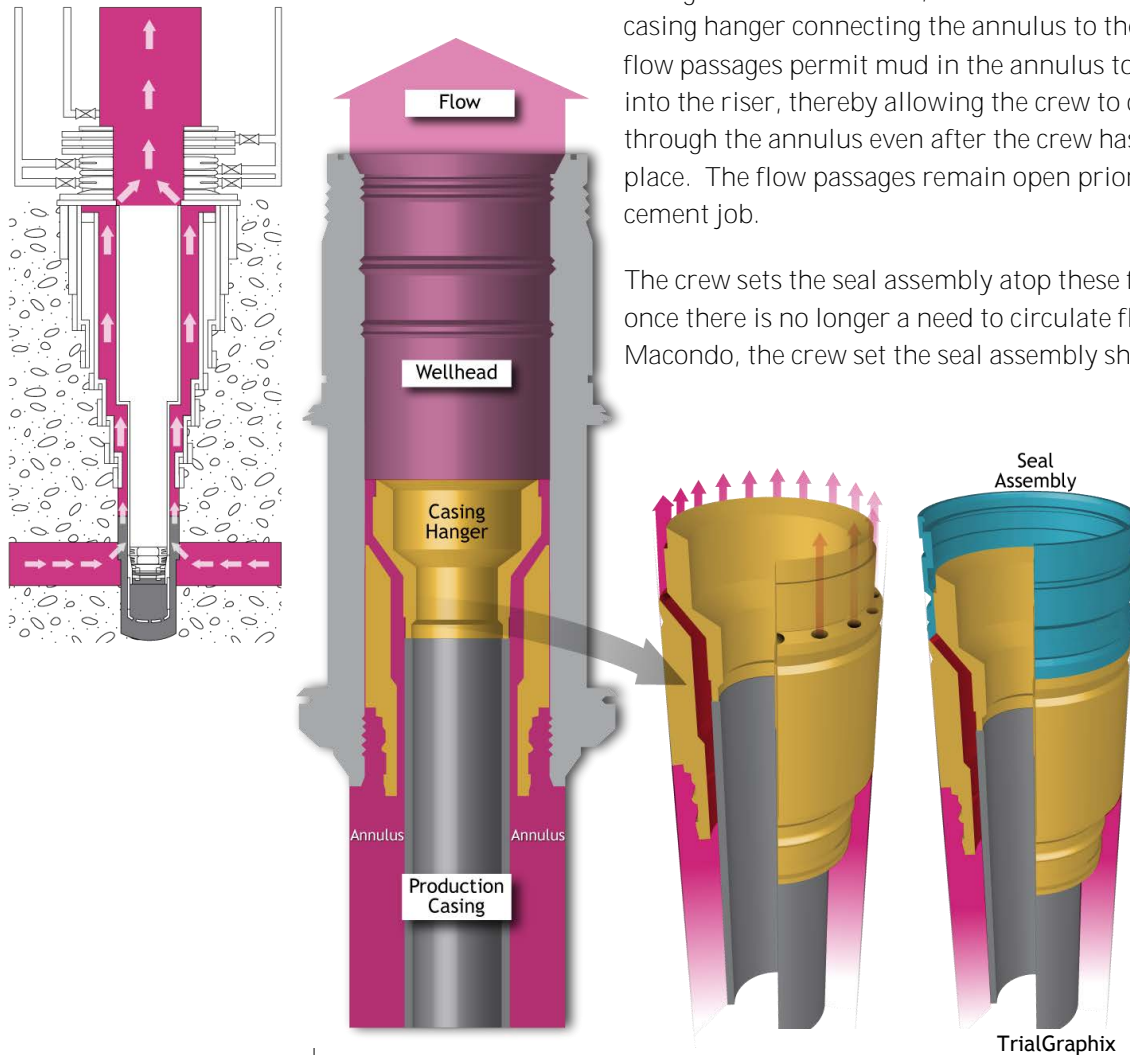
Figure 4.1.2.
Flow through the
seal assembly.

As Figure 4.1.2 illustrates, there are small **flow passages** through the casing hanger connecting the annulus to the inside of the wellhead.³ The flow passages permit mud in the annulus to flow into the wellhead and up into the riser, thereby allowing the crew to circulate drilling fluids through the annulus even after the crew has set the production casing in place. The flow passages remain open prior to and during the final cement job.

First, there could have been a leak through the flow passages. This might have occurred because debris obstructed the seal area during the setting process, the seal failed to expand and set properly, or the seal dislodged after it was set.⁴

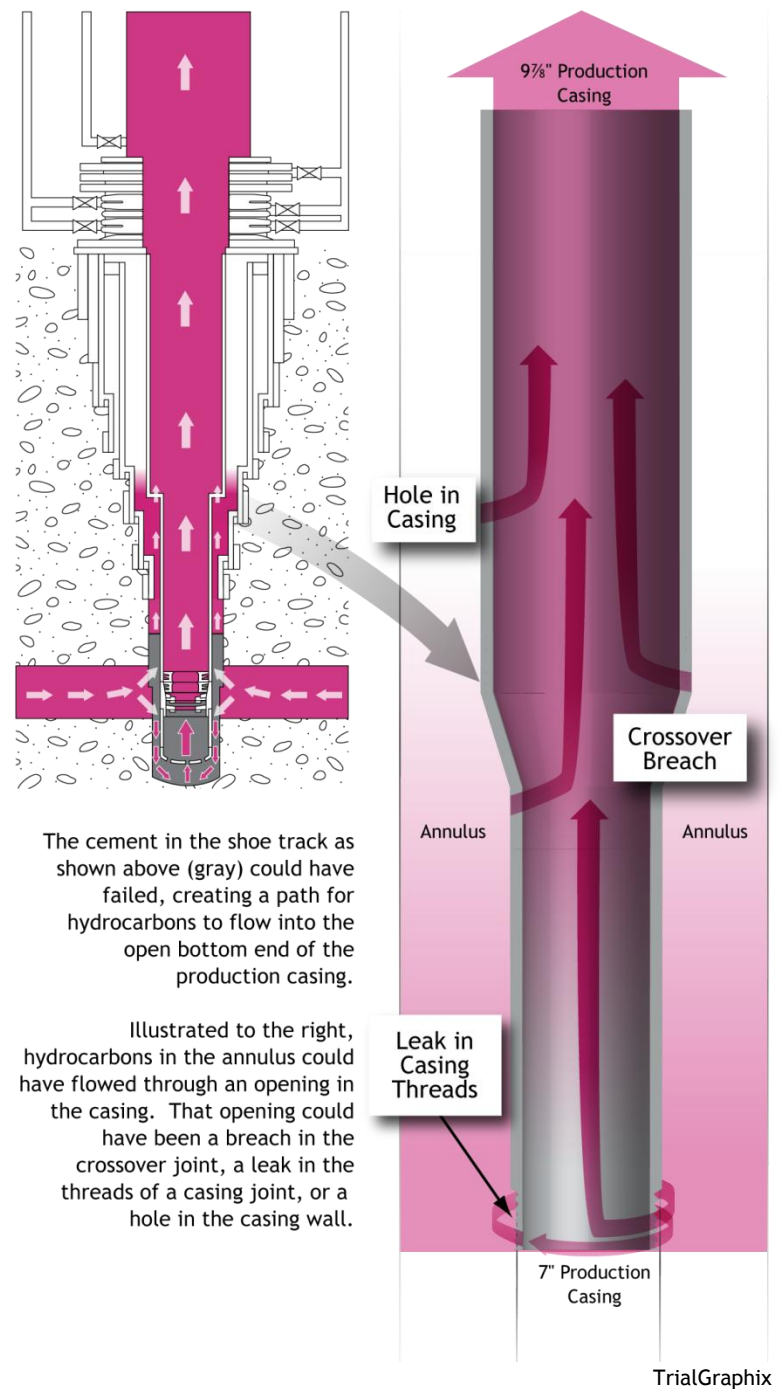
Figure 4.1.3. Flow up the production casing.

Second, hydrocarbons in the annulus could have flowed into the production casing through an opening in the casing. That opening could have been a breach in the 9 $\frac{7}{8}$ -inch \times 7-inch tapered crossover joint,⁸ a leak in the threads of a casing joint,⁹ or a hole in the casing wall, as illustrated in Figure 4.1.3.

The Chief Counsel’s team finds that hydrocarbon flow came up through the production casing, most likely due to a failure of the shoe track cement.¹⁹

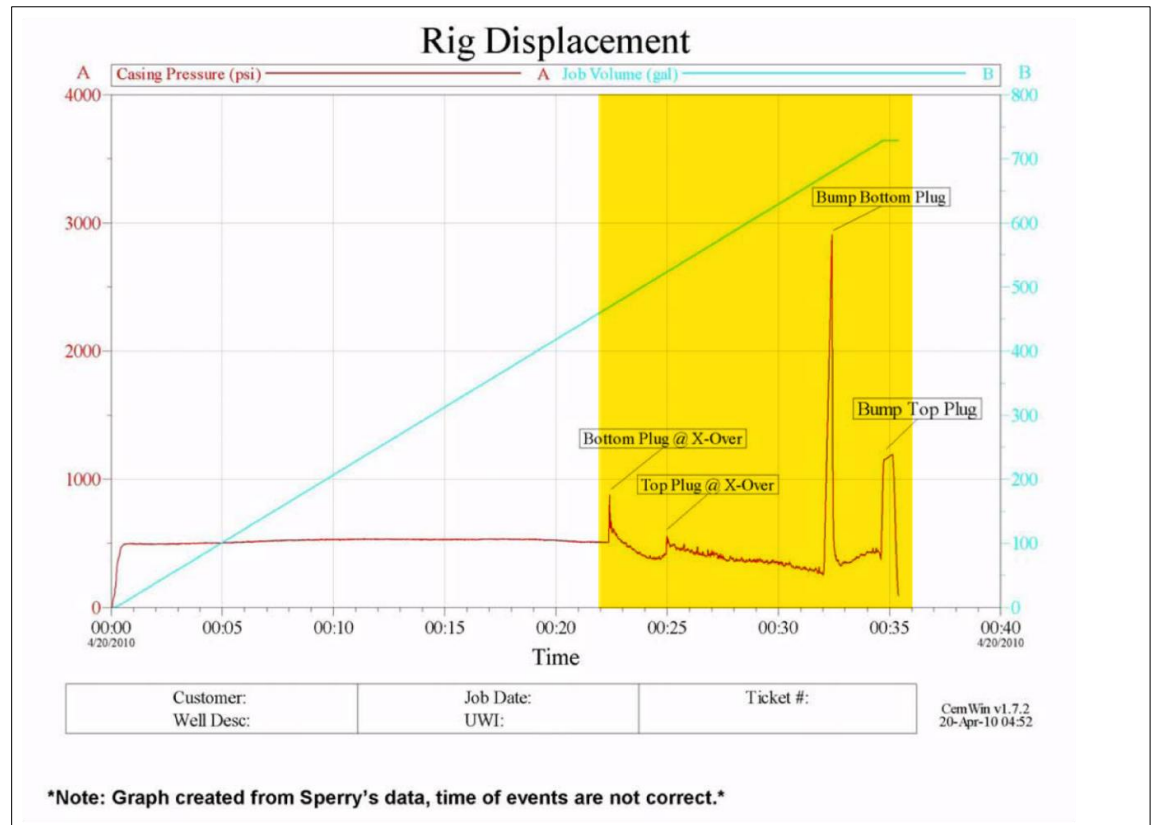
Figure 4.1.7. Halliburton post-cement-job report.

First, the observed fluctuation in surface pressure can be explained by the wellbore geometry at Macondo.⁶³ Macondo had a **tapered** production casing string—9⁷/₈ inches from wellhead to 12,488 feet below sea level, tapering to 7 inches from 12,488 feet below sea level to the bottom of the casing. In wells with a tapered production casing (and hence a tapered annulus), “each discrete volume of fluid will grow in column height as it travels down the well [past the crossover joint] and shrink as it comes up the well [past the crossover joint].”⁶⁴ As a result, the hydrostatic pressure differential between the casing and the annulus will change over the course of the cement job (as it did at Macondo).

Finally, the cement job pressure readings cannot alone support a theory of annular flow (a point that Halliburton concedes⁶⁷), and the other evidence discussed above is inconsistent with annular flow.

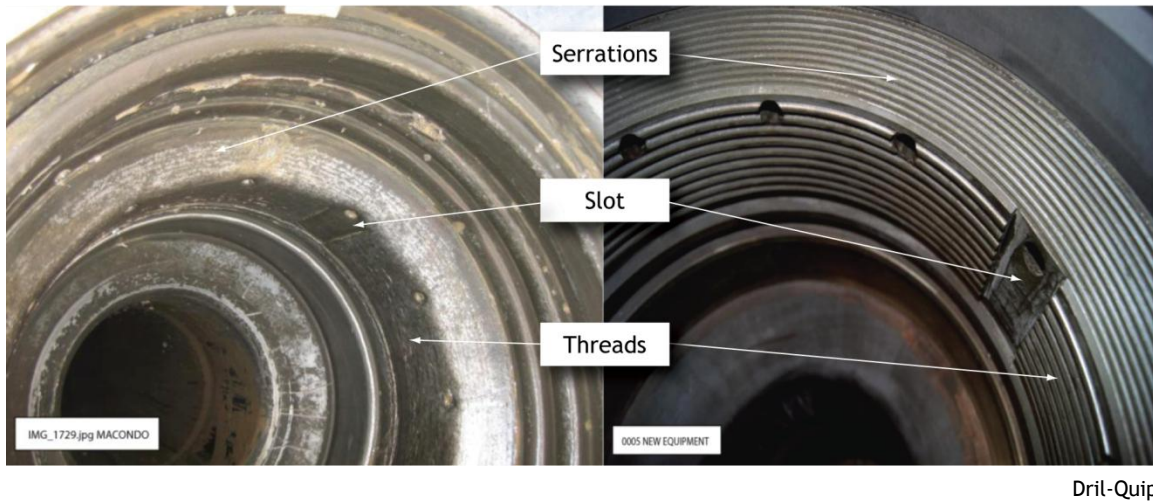
Figure 4.1.8. Erosion of the inside of the casing hanger.

Post-blowout inspection of the production casing hanger and seal assembly retrieved from the Macondo well shows severe erosion on the inside of the casing hanger (shown in the left-side photo in Figure 4.1.8). Serrations near the top of the casing hanger—normally $\frac{1}{8}$ -inch deep—are almost completely abraded away.⁶⁸ Threads that normally run around the inside of the casing hanger are flattened.⁶⁹ The slot that normally interrupts the threads— $\frac{1}{4}$ -inch deep when new—appears as an almost nonexistent indentation.⁷⁰ These observations all suggest that hydrocarbons came up through the production casing.

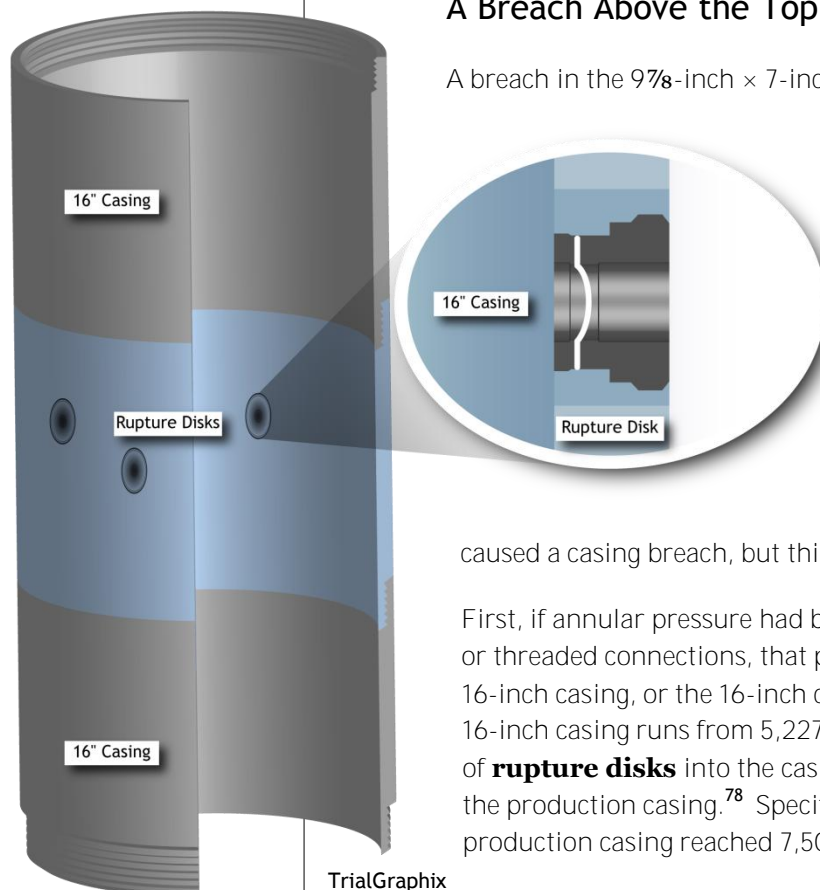
Figure 4.1.9. 16-inch casing and rupture disks.

Hydrocarbons may have entered through a breach in the production casing, although the Chief Counsel's team considers this scenario unlikely.

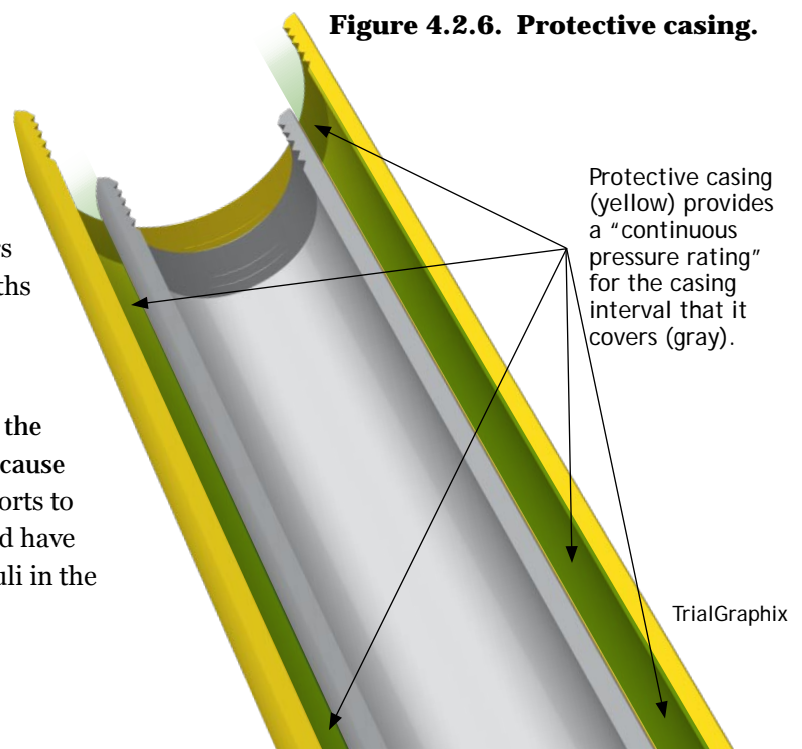
Figure 4.2.6. Protective casing.

BP's well design consistently and deliberately omitted a **protective casing**. A protective casing is an intermediate casing string outside the production casing that runs from deep in the well all the way back to the wellhead.²³ A protective casing supplies a "continuous pressure rating" for the interval that it covers (as shown in Figure 4.2.6) and seals off potential leak paths at the tops of previous liner hangers.²⁴

It is common industry practice to use a protective casing whenever running a long string production casing.²⁵ But the Macondo team never planned for a protective casing²⁶ because installing such a casing would also have negated their efforts to mitigate annular pressure buildup.²⁷ Specifically, it would have sealed off the rupture disks and the previously open annuli in the casing design.

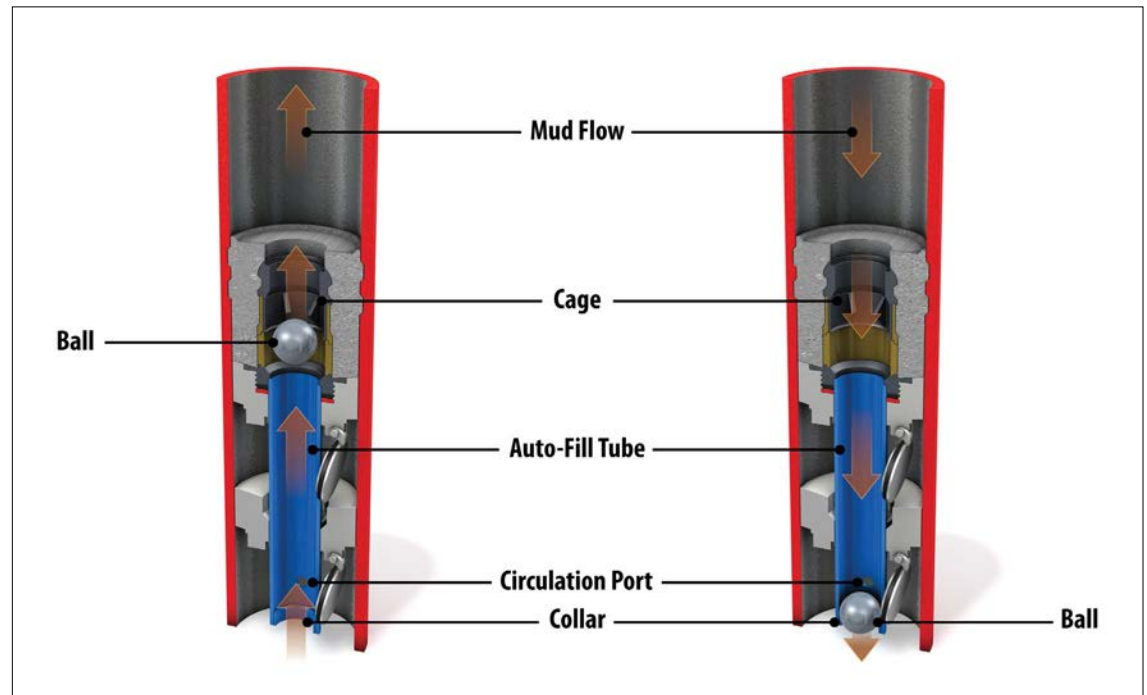
Figure 4.3.17. Auto-fill float collar.

The float collar's auto-fill tube contains a 2-inch weighted ball, which is free to move within the tube but not out of it. At the top of the float assembly is a plastic cage that prevents the ball from escaping but allows mud to flow through. At the bottom is a phenolic resin collar that is less than 2 inches in diameter, which also allows mud, but not the ball, to flow through. When casing is being run, mud flowing up through the tube pushes the ball against the inside of the cage. When the casing lands, the ball falls to and plugs the bottom of the tube, leaving two small holes on the side of the tube as the only path through the tube for mud circulated down through the well.¹⁴⁵

Flow while casing is being lowered (left) and flow during conversion (right).

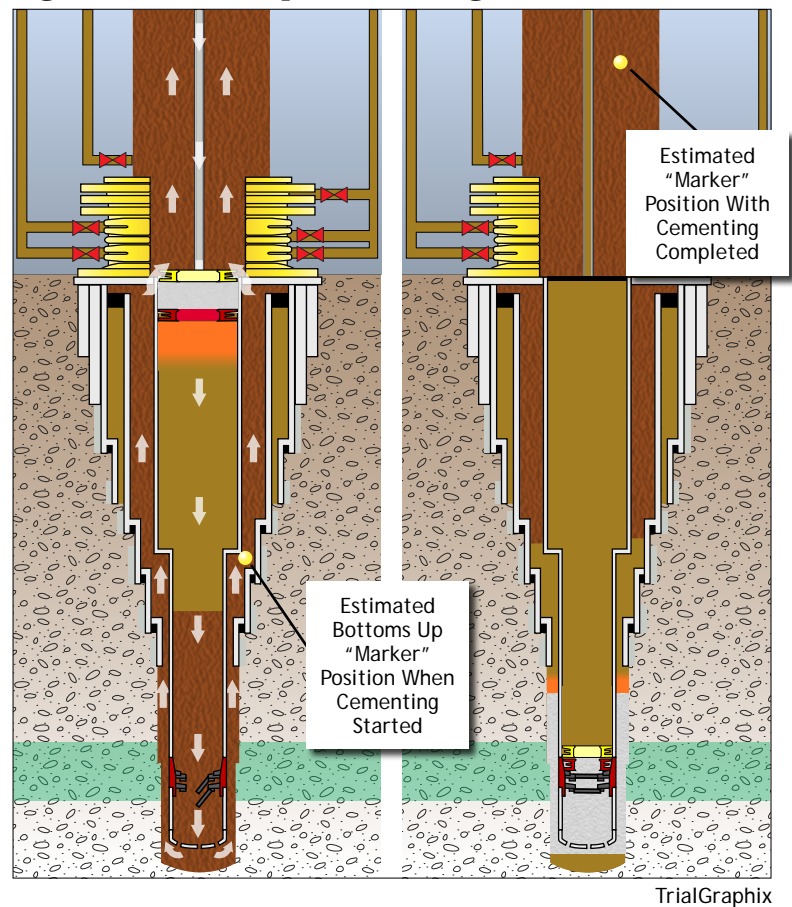
Figure 4.3.18. BP's pre-cementing mud circulation.

At approximately 4:18 p.m. on April 19, the rig crew re-established mud circulation after running the long string.¹⁹⁹ The rig crew then circulated a total of approximately 350 barrels of mud at rates up to 4 bpm before beginning the cementing process.²⁰⁰ This figure exceeds the 261 bbl called for in the April 18 Halliburton cement job procedure²⁰¹ but is significantly lower than the 2,760 bbl required for a full bottoms up.²⁰²

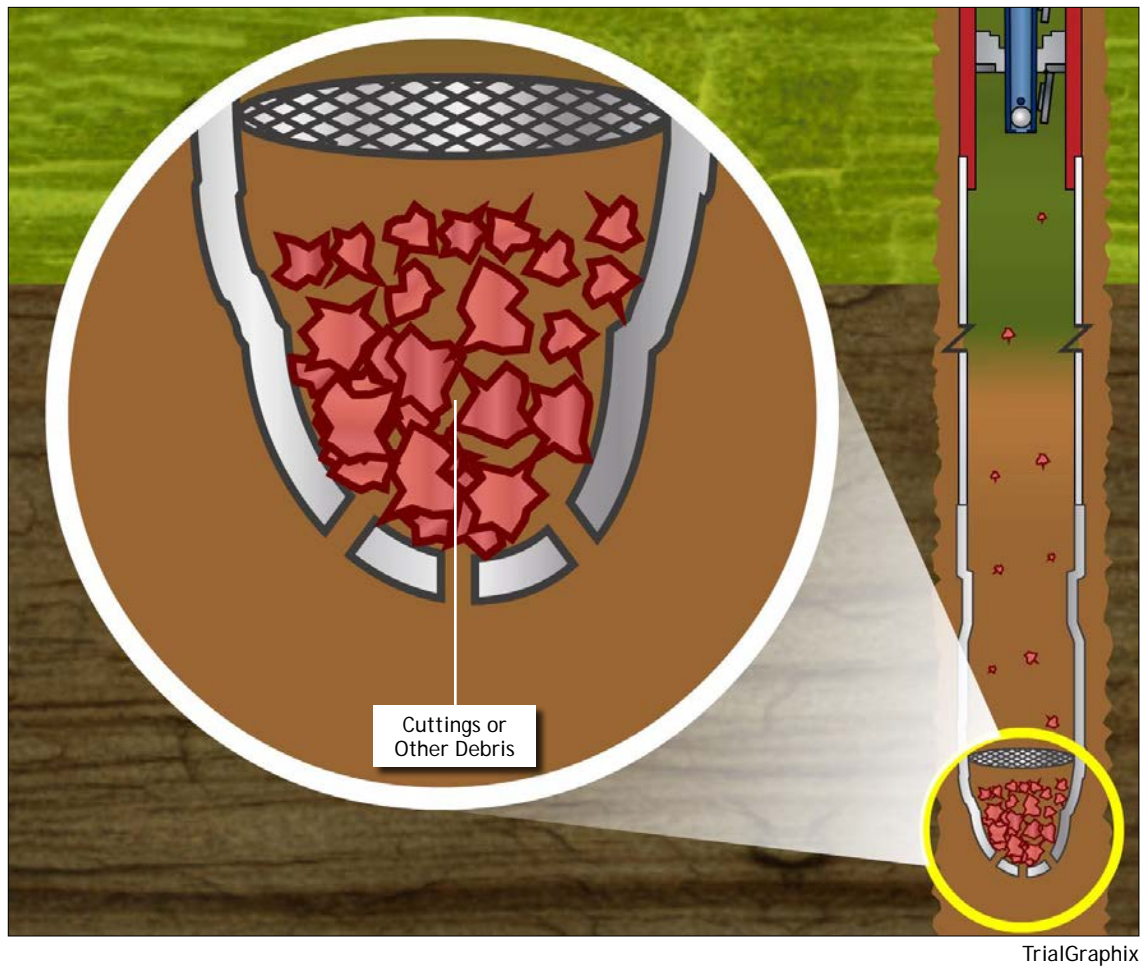
Figure 4.3.20. Clogged reamer shoe.

Drilling mud pumped down the Macondo production casing and through the float collar assembly had to exit the bottom of the casing through three 1⁵/₈-inch holes ("circulation ports") at the

bottom of the reamer shoe.³⁰⁵ Debris and/or cuttings may have plugged these holes during the course of casing installation as shown in Figure 4.3.20. This could explain why the rig crew was unable initially to establish mud circulation after landing the production casing. It could also explain why the pressure dropped suddenly from 3,142 psi—that pressure may have been sufficient to clear a clog in the reamer shoe to allow mud to flow again.

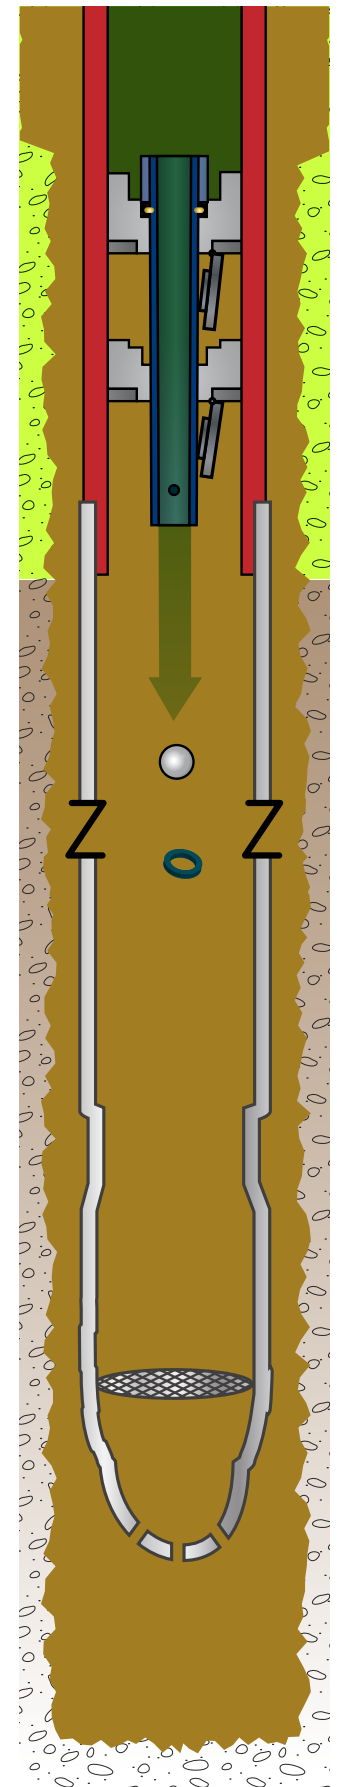
Figure 4.3.21. Ball forced through tube.

A second possibility, shown in Figure 4.3.21, is that the sudden pressure drop may have been caused when pump pressure forced the ball inside the auto-fill tube through the end of the auto-fill tube. The collar that would normally have retained the ball within the auto-fill tube was held in place with brass pins. It is possible those pins and the collar failed, allowing the ball to pass through.³⁰⁹ This would have left the auto-fill tube in place between the float valves and created a path for flow in either direction.

If the ports in the bottom of the auto-fill tube were clogged, the rig pumps may have placed enough force on the collar to shear the brass pins instead of the pins holding the auto-fill tube in place. Clawson informed Morel on April 19 that it would only take 1,300 psi of pressure to force the ball through the collar without converting the float valves.³¹⁰ It is not apparent whether Morel considered or informed others of this possibility.³¹¹

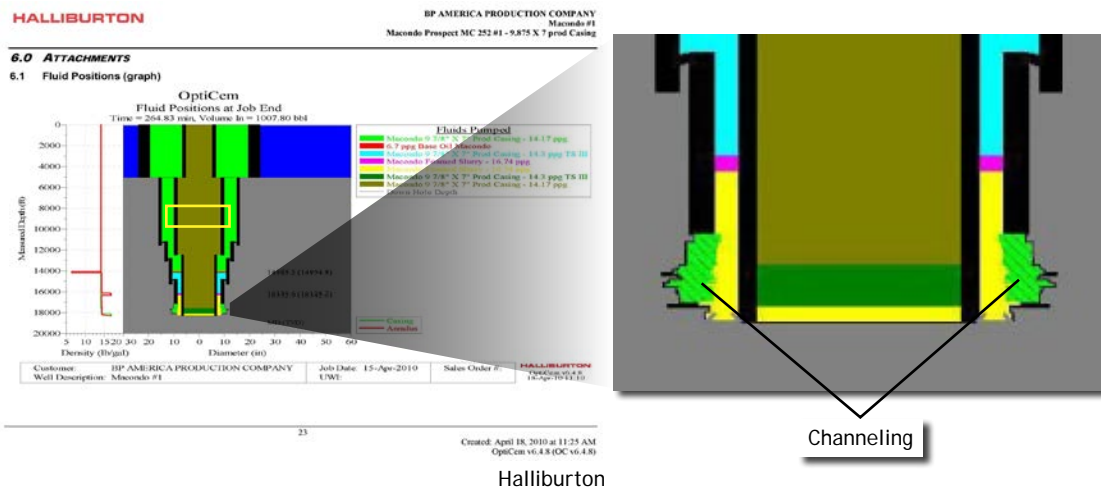
Figure 4.3.22. Page 23 of Halliburton's April 18, 2010 OptiCem™ report.

Halliburton personnel explained the green areas as predicted channeling.

the report. Instead, the reports presented information in an obscure and unnecessarily technical manner. (For instance, as shown in Figure 4.3.22, the reports present channeling predictions only as unexplained jagged lines in a well diagram).³⁶⁷ As a result, BP engineers reviewed the predictions in a cursory fashion, if at all.³⁶⁸

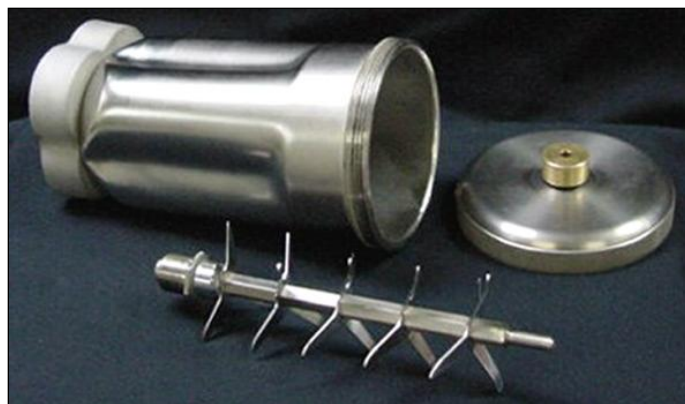
Figure 4.4.1. Foam testing apparatus.

The technician mixes a volume of base cement slurry with air (not nitrogen) in a sealed blender to generate a foamed slurry of the same density that will be used in the field (see Figure 4.4.1). The laboratory may then conduct foam stability tests using one of two methods.

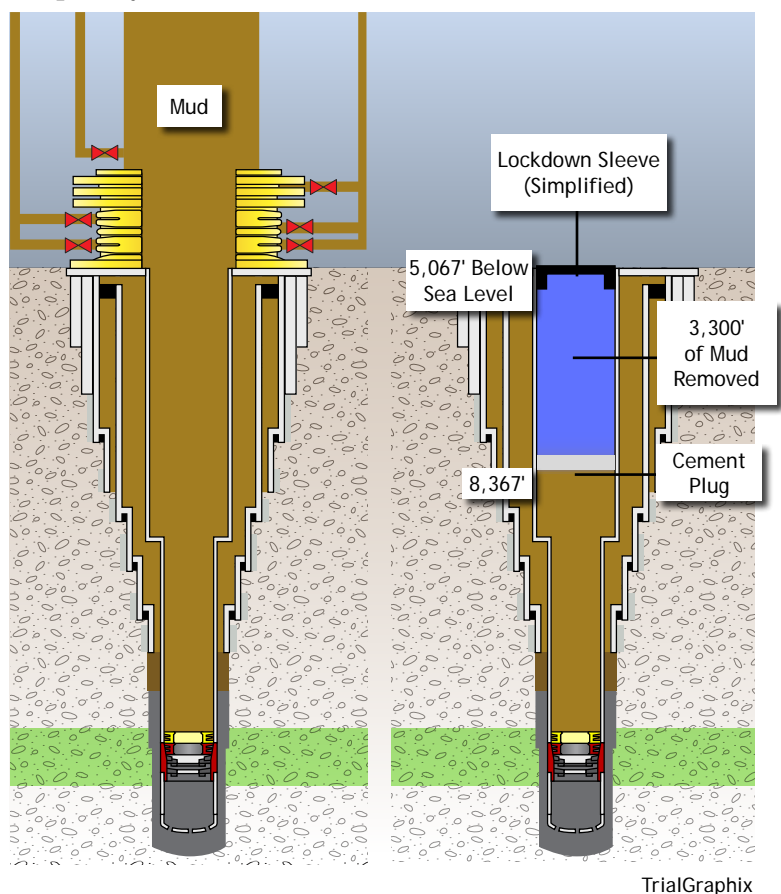
Figure 4.5.1. Planned configuration after temporary abandonment.

After finishing cementing the production casing (left), the rig crew began temporary abandonment procedures that would have allowed the *Deepwater Horizon* to remove its riser and BOP from the well and move on to another job (right). The blowout occurred before the rig crew set the cement plug and lockdown sleeve.

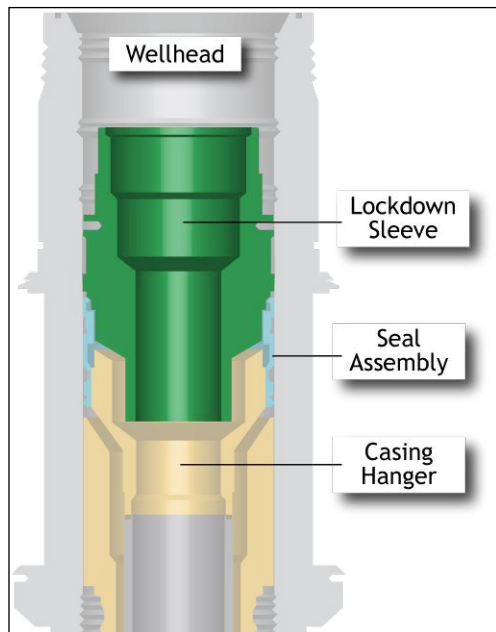
Figure 4.5.2. Lockdown sleeve.

- BP engineers decided to set the lockdown sleeve during temporary abandonment because the *Deepwater Horizon* could do that job more quickly and efficiently than a completion rig.
- Having decided to set the lockdown sleeve during temporary abandonment, BP engineers wanted to ensure that other temporary abandonment operations would not damage the sleeve. To address this concern, they decided to set the sleeve last.⁴

BP's desire to set a lockdown sleeve during temporary abandonment drove the development of its temporary abandonment procedure. The lockdown sleeve locks down the casing hanger and seal assembly.

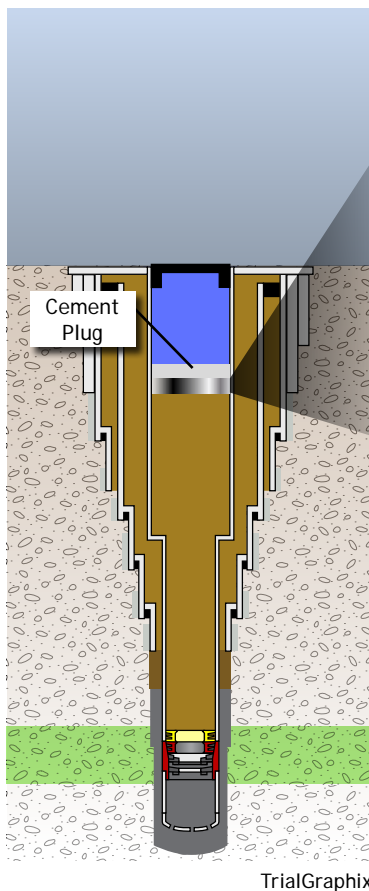
Figure 4.5.5. Bridge plug.

BP could have used a mechanical plug in lieu of or in addition to a cement plug.

seawater.¹⁰⁵ Setting a cement plug in mud can present a risk of contamination and certain other chemical complexities.¹⁰⁶ But contamination issues can exist with cement plugs set in seawater as well,¹⁰⁷ and the complexities can be managed with proper cement slurry design and the use of spacer.¹⁰⁸ In order to help ensure that cement plugs set in drilling mud are secure, engineers also use **mechanical retainers** or **bridge plugs**—metal and rubber devices that fit into the casing and hold the cement,¹⁰⁹ as shown in Figure 4.5.5. The mechanical plug then serves as an additional barrier, apart from the cement it helps to set.¹¹⁰

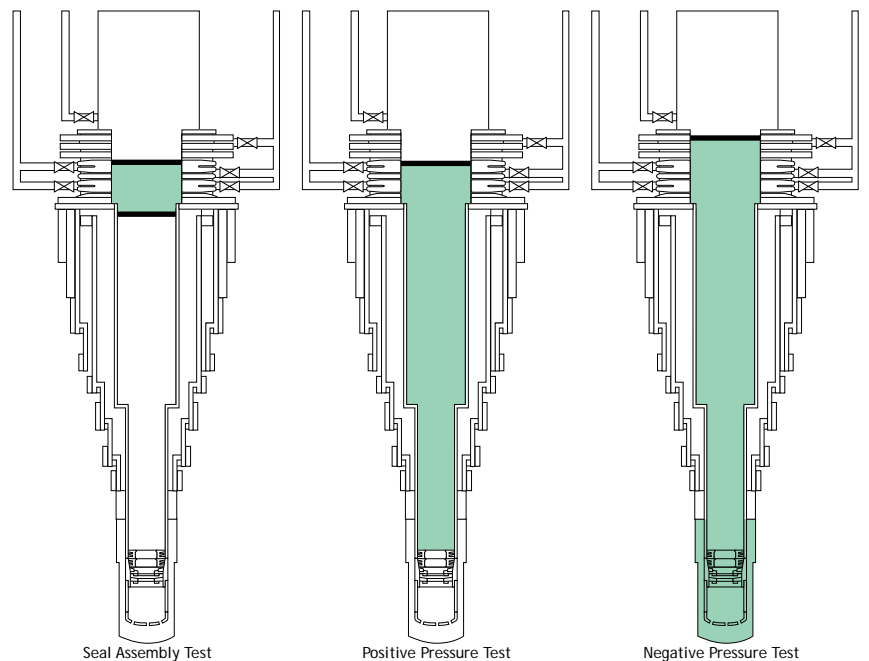
Figure 4.6.1. Well integrity tests.

The rig crew conducted three pressure tests as part of the temporary abandonment procedure to verify the integrity of the well. From left to right: the seal assembly test, the positive pressure test, and the negative pressure test. Test regions are shown in green.

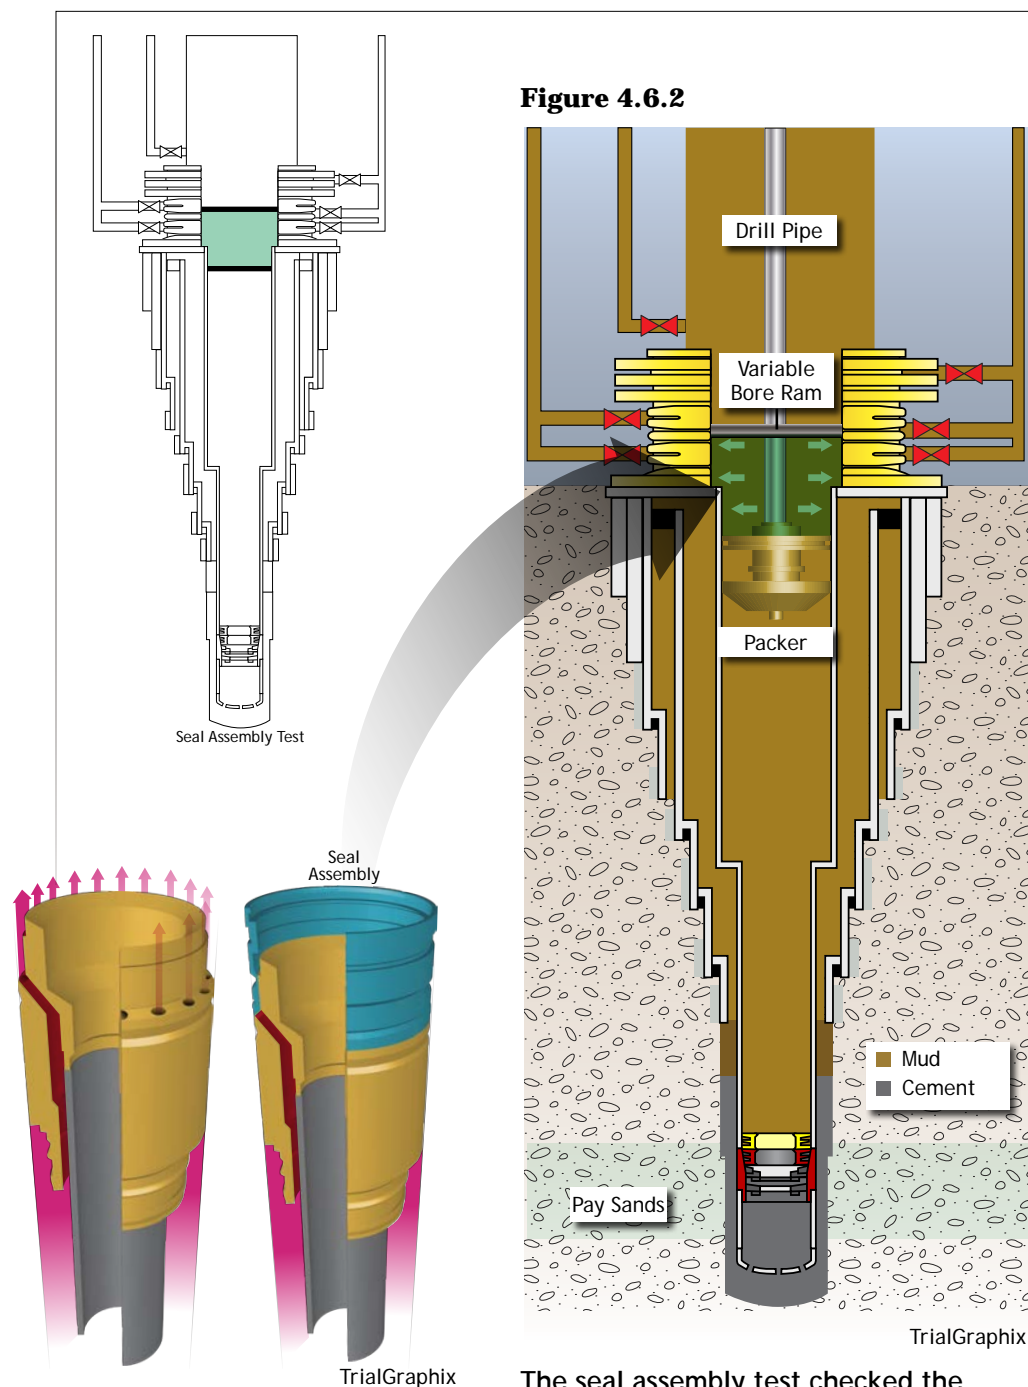
Figure 4.6.2

The casing hanger, as described in Chapter 4.1, has flow passages that facilitate the flow of fluids during normal drilling operations. The seal assembly (blue) is fitted atop the casing hanger to halt annular flow after the primary cement job is complete. Together, the two bind the casing to the wellhead.

The seal assembly test checked the integrity of the interface between the casing and the wellhead. After lowering a packer into the well, the rig crew closed a variable bore ram around the BOP, sealing the space above and below the seal assembly. The rig crew then pumped fluid into this space, increasing the pressure inside it. If fluid did not leak out of the seal assembly, the pressure would remain constant.

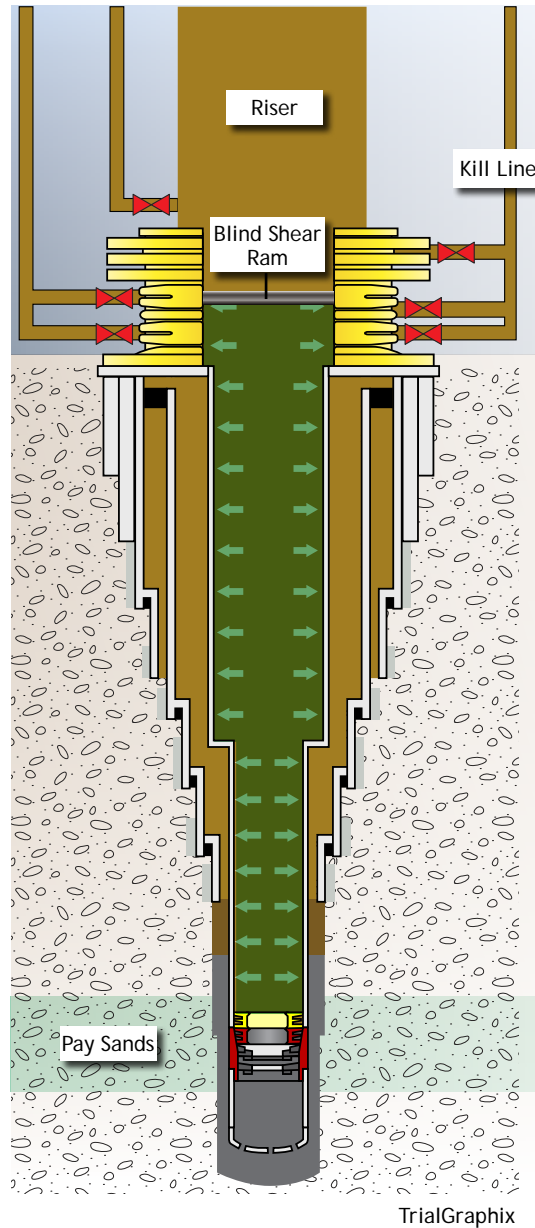
Figure 4.6.3

The positive pressure test checks the integrity of the well by testing whether the casing and wellhead seal assembly can contain higher pressure than surrounds them. The *Deepwater Horizon* crew increased the pressure in the production casing string by pumping fluid into it through the kill line. If fluid does not leak out of the casing, the pressure again remains constant.

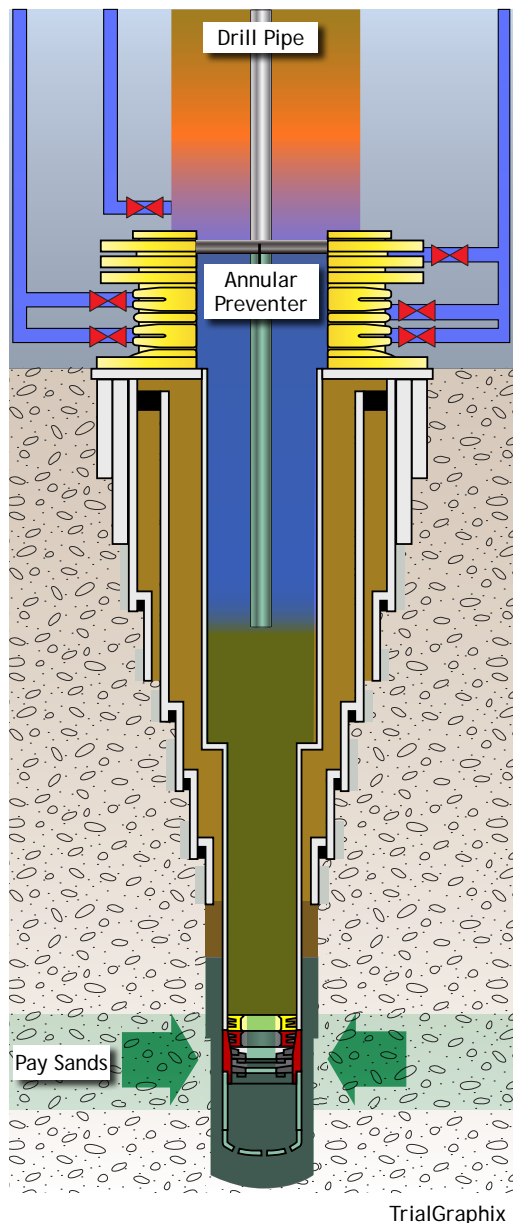
Figure 4.6.4

By moving mud from the production casing into the riser (displacement), the rig personnel reduced the pressure inside the well below the pressure outside the well (underbalancing). If there was good well integrity, the pressure inside the well would remain constant during the negative pressure test. If there was a leak of hydrocarbons into the well, the pressure in the well would rise (if the drill pipe or lines to the rig were closed) or fluid in the wellbore would be forced up and flow out at the rig (if the lines were open).

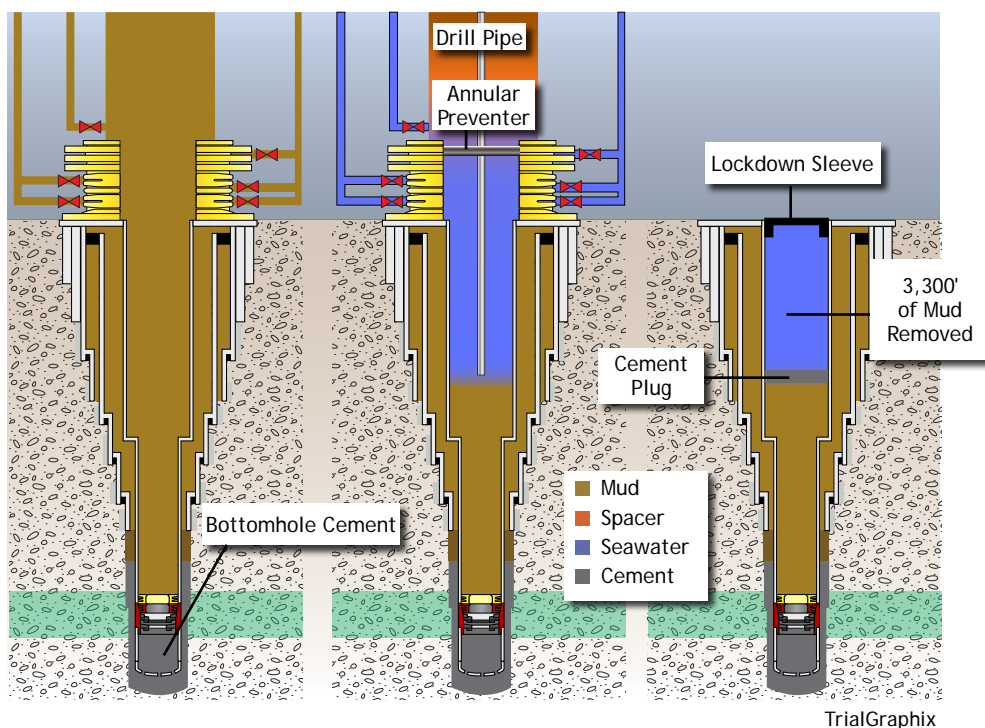
Figure 4.6.5. End of cement to temporary abandonment.

After the final casing string was cemented, heavy drilling mud filled the riser and the well (left). After the temporary abandonment planned for Macondo, the riser and its drilling mud would be removed. The drilling mud in the final casing string would be replaced with lighter seawater to a depth of over 8,000 feet below sea level (right). The removal of the hydrostatic pressure this drilling mud applied to the bottom of the well would increase the stress on the casing, seals, and cement. The negative pressure test simulated the conditions of temporary abandonment to confirm the integrity of the well in a controlled environment (middle).

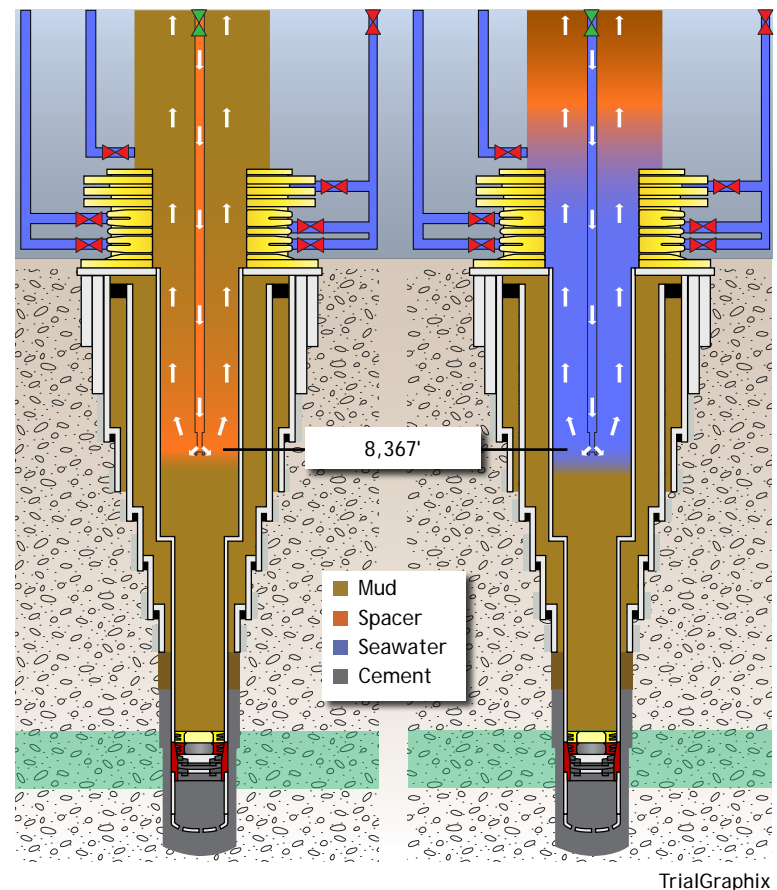
Figure 4.6.6. Preparations for the negative pressure test.

To prepare for the negative pressure test, the rig crew needed to displace the mud in the drill pipe and casing string from a depth of 8,367 feet to above the BOP. The crew did so by pumping spacer fluid (left) and then seawater (right) down the drill pipe until the mud was above the BOP.

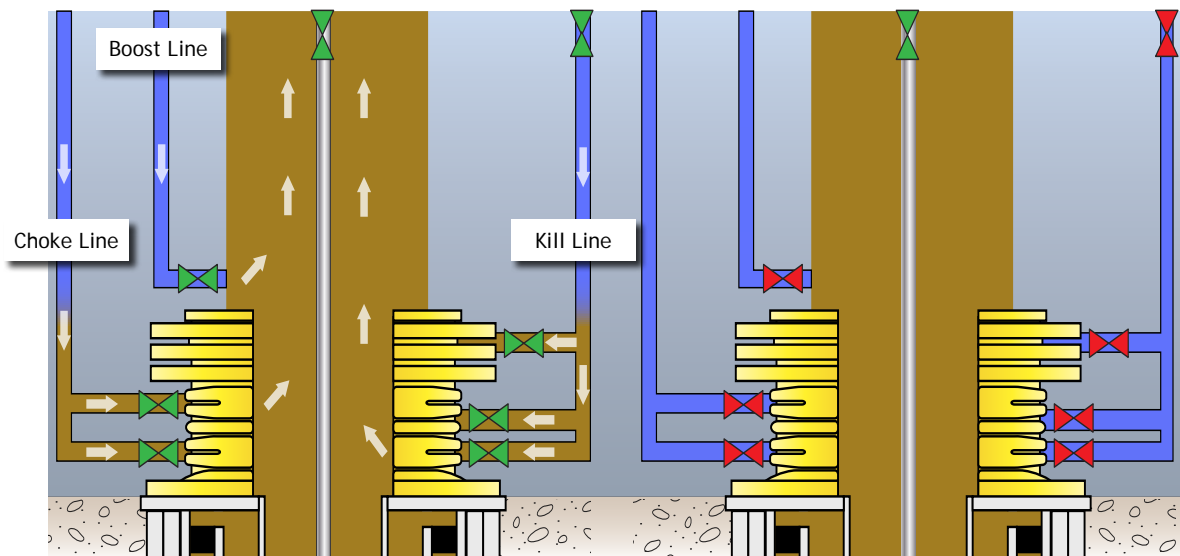
Figure 4.6.9. Negative pressure test progress, 3 p.m. on April 20, 2010.

Shortly after 3 p.m., Transocean driller Dewey Revette pumped water to displace mud from three pipes, or "lines," that ran from the rig to the BOP stack: the **boost**, **choke**, and **kill lines** (see Figure 4.6.9).

To begin preparations for the negative pressure test, the rig crew displaced the boost, choke, and kill lines with seawater. Seawater was pumped into the lines on the rig, forcing mud into and up the riser (left). After the lines were displaced, the crew closed the valves connecting them to the riser and BOP (right).

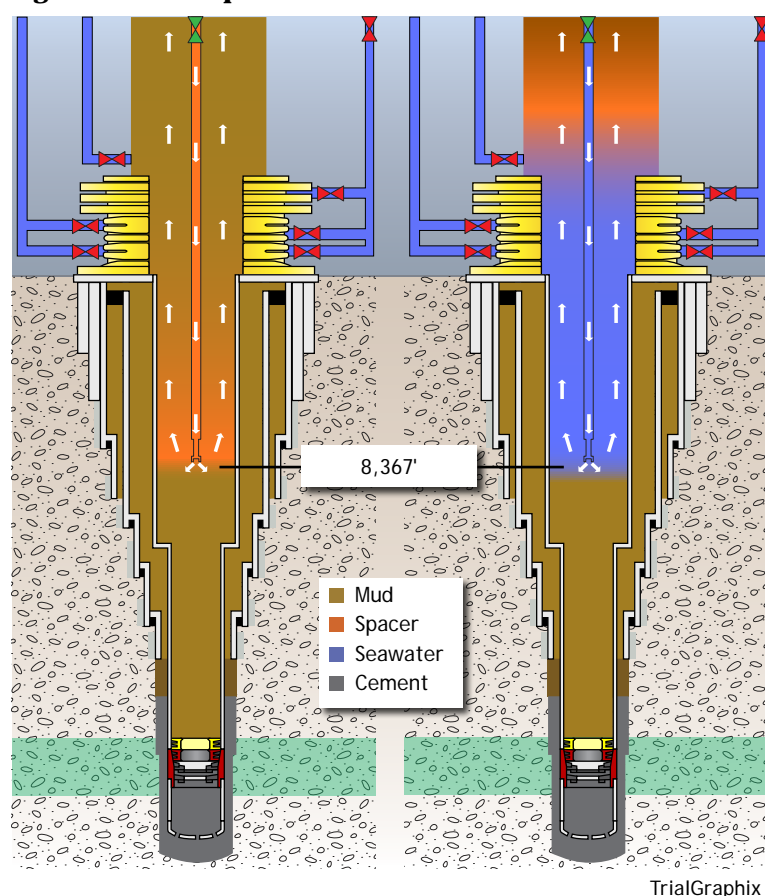
Figure 4.6.10. 4 p.m.

The crew displaced the mud in the drill pipe and in the casing from 8,367 feet to above the BOP. The crew first pumped a spacer fluid down the drill pipe, which forced the mud out and up the casing and the riser (left). Following the spacer, the crew pumped seawater into the drill pipe. This forced the spacer and the mud up the casing. The crew’s intent was to pump enough seawater to displace the spacer and mud above the BOP (right).

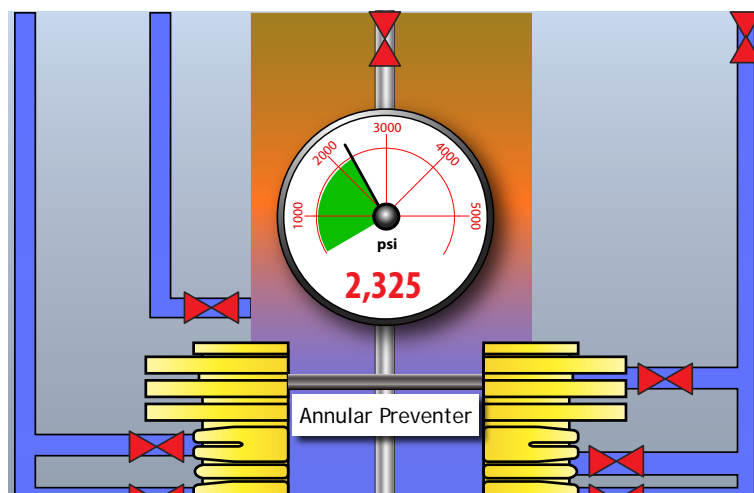
Figure 4.6.11. 4:53 p.m.

After pumping 352 barrels of seawater behind the spacer, the crew closed the upper annular preventer, believing that they had displaced all of the spacer above the BOP.²⁵ BP's post-incident report calculates that the crew was correct, albeit by a slim margin of just 12 feet.²⁶ But that calculation is optimistic. It assumes that none of the heavy spacer fell back down through the much lighter seawater that was pushing it upward through the wellbore. Given the substantial density differential between the spacer and seawater and the substantial amount of time it took to displace 454 barrels of spacer, it is likely that at least some of the spacer fell backward through, or mixed with, the seawater on its way up the casing into the riser. Even putting aside that complication, Transocean and at least one independent expert have calculated that the tail end of the spacer did not end up above the BOP.²⁷

The crew closed the annular preventer around the drill pipe. The drill pipe pressure was approximately 700 psi higher than should have been expected, a sign that some spacer may have remained beneath the BOP.
