Macondo

T H E G U L F O I L D I S A S T E R

Chief Counsel's Report | 2011

National Commission on the BP Deepwater Horizon Oil Spill and Offshore Drilling

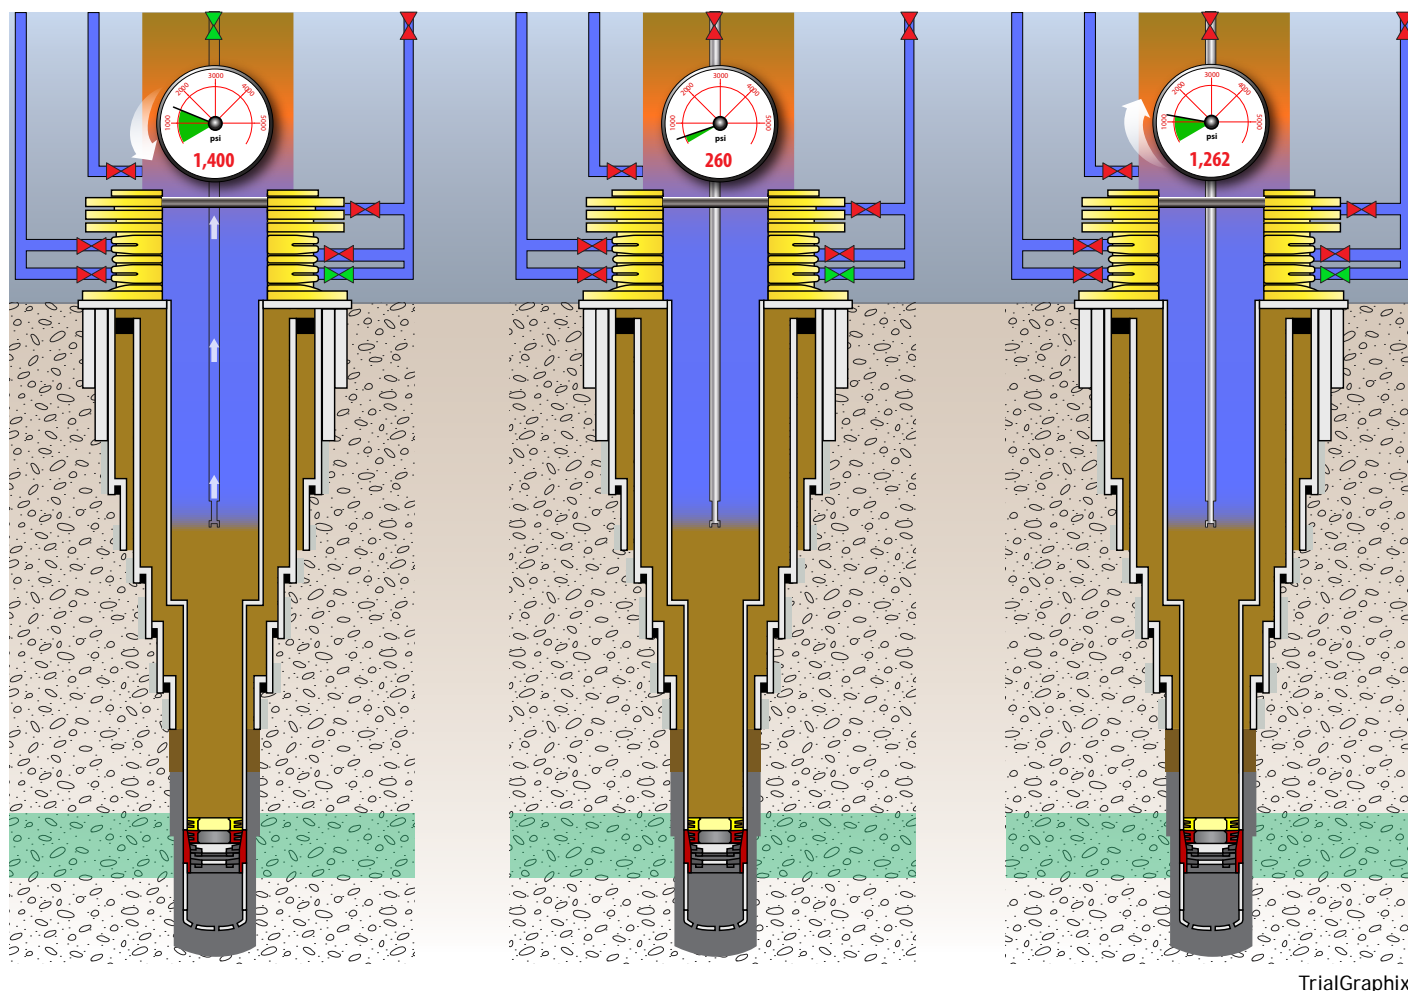
Figure 4.6.13. 4:58 p.m.

The crew began the negative pressure test by attempting to bleed the drill pipe pressure to 0 psi (left). However, the crew was unable to reduce pressure to below 260 psi (middle). This bleed returned an unknown amount of water to the rig. The crew shut in the drill pipe, and the pressure built up to 1,262 psi (right). In a successful negative pressure test, pressure does not build up.

well during the bleed, even though such calculations would have been relatively straightforward.³⁷ After failing to bleed the pressure down to 0 psi, the crew closed the valve on the drill pipe, and the pressure built back up to 1,262 psi.³⁸

As one independent expert has pointed out, this series of events actually constituted a failed negative pressure test, although the crew did not recognize that fact.⁴⁰

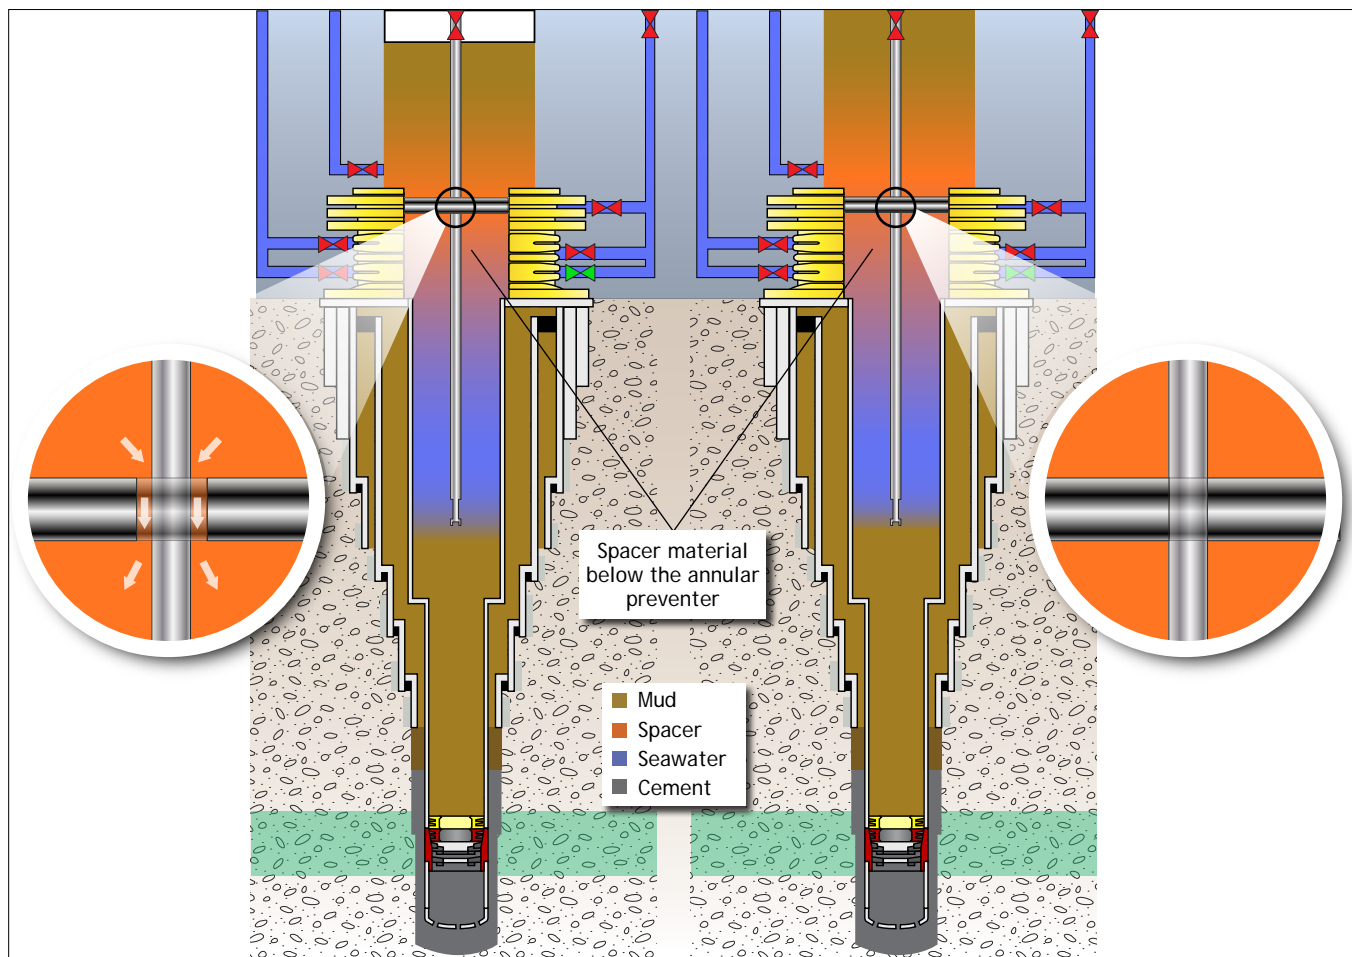
Figure 4.6.14. 5:10 p.m.

The rig crew noticed that the fluid level in the riser was falling. Because the annular preventer was not sufficiently tight around the drill pipe, spacer fell beneath the BOP (left). In response, the rig crew tightened the seal of the annular preventer and refilled the riser (right), but did not circulate the spacer back above the BOP.

At 5:10 p.m., the rig crew apparently noticed that the level of fluid in the riser was falling.⁴¹ Spacer in the riser was leaking down through the annular preventer and into the well below the BOP.⁴² Unlike many other indications, the crew could observe the fluid levels in the riser with their own eyes. When one rig crew member arrived on the rig floor, he saw others standing around the rotary table and using a flashlight to peer down into the riser to see how much fluid was missing.⁴³

In response to the dropping levels of fluid in the riser, Harrell instructed the rig crew to tighten the seal of the annular preventer against the drill pipe as shown in Figure 4.6.14. Wyman Wheeler, the Transocean toolpusher on duty at the time, then topped off the riser with 20 to 25 barrels of mud, and the fluid level in the riser stayed steady.⁴⁶ The crew had thus identified and eliminated a leak in the well system that could have explained the anomalous pressure readings they had seen and their inability to bleed the drill pipe pressure to 0 psi.⁴⁷ By this time Kaluza returned to the rig floor.⁴⁸

Despite clear evidence that spacer had probably leaked below the BOP, rig personnel again did nothing to ensure that they had fully displaced the spacer above the BOP and instead proceeded with the test.⁴⁹

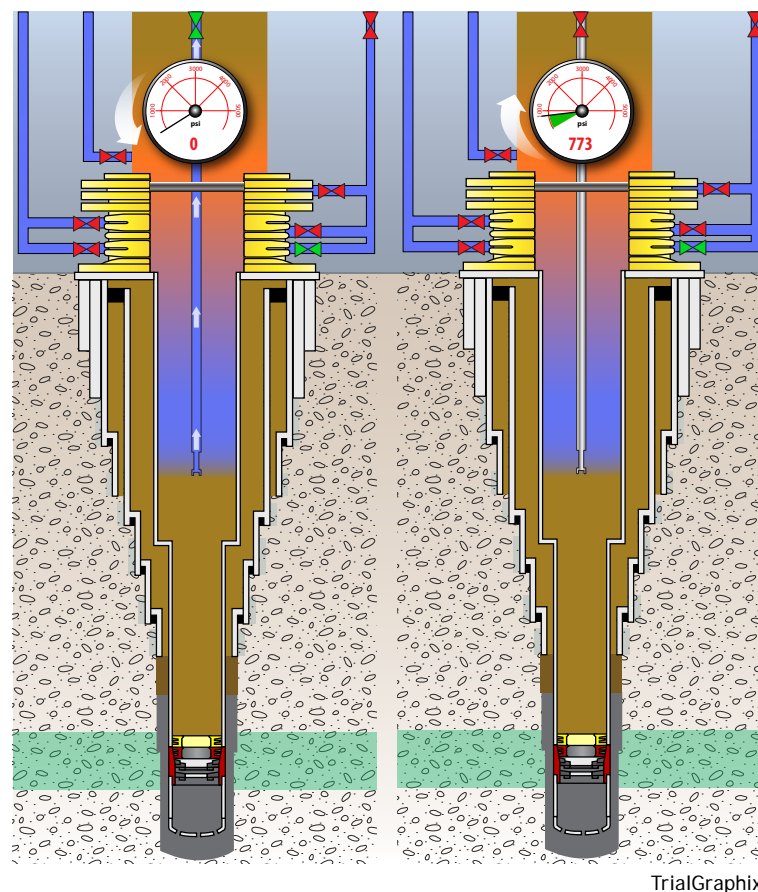
Figure 4.6.15. 5:26 p.m.

This second series of bleed-offs, excessive flows, and pressure buildups constituted another failed “negative pressure test” that the crew again did not recognize as such. With the annular preventer fully closed and sealed, the only explanation for the excessive returns and pressure increase would be that the primary cement job had failed to seal off the pay zone. Hydrocarbons were leaking from the formation into the well. Individuals involved in the test at this point should have recognized that the well lacked integrity.

The rig crew attempted again, this time successfully, to bleed the drill pipe pressure down to 0 psi. Fifteen barrels of seawater were returned during this bleed (left). The drill pipe was shut in, but the drill pipe pressure rose to 773 psi. Fifteen barrels is a higher return than should have been expected, and the drill pipe pressure should not have built back up.

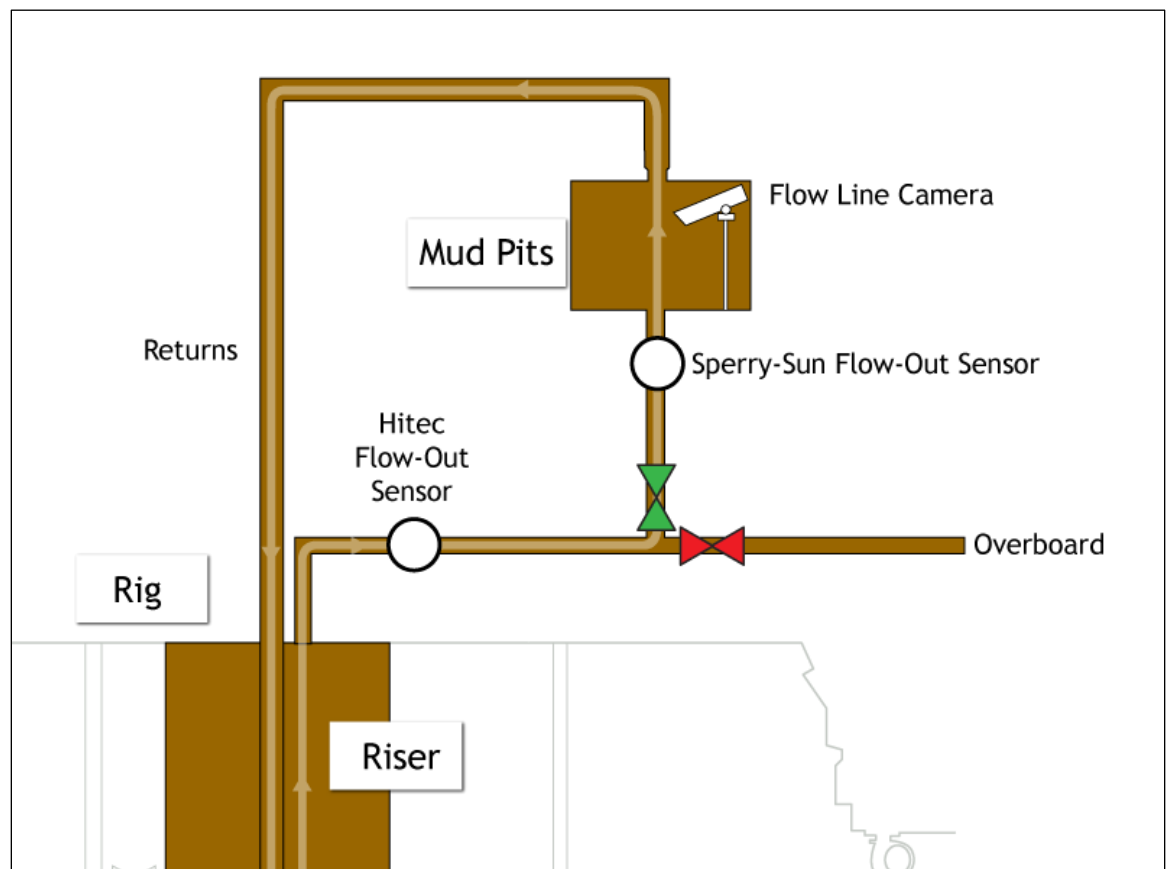
Figure 4.7.5. Flow-out sensors and flow line camera.

The Sperry-Sun flow-out sensor and the rig's flow line camera could not register returns going overboard. The Hitec flow-out sensor could, but data from the Hitec flow-out sensor sank with the rig.

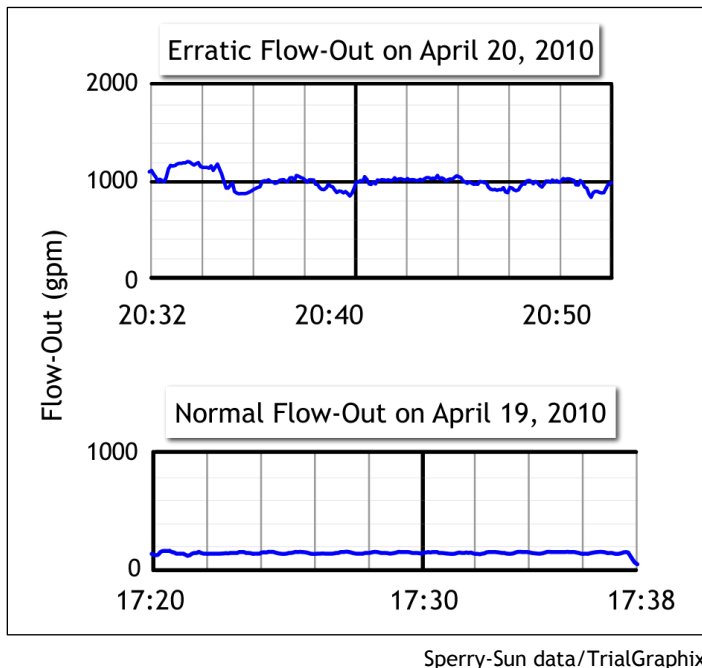
Figure 4.7.8. Erratic vs. normal flow-out.

This setup should not have impaired rig personnel's ability to monitor flow-out versus flow-in. However, the flow-out readings appear to have been more erratic than readings captured the previous day (seen in Figure 4.7.8). This may be because cranes were moving on the rig's deck, causing the rig to sway and thus affecting the level of fluids in the flow line.¹¹⁶ Otherwise, flow-out appeared normal.¹¹⁷

Flow-out readings appear to have been more erratic than normal during the final displacement, perhaps because crane operations were causing the rig to sway.

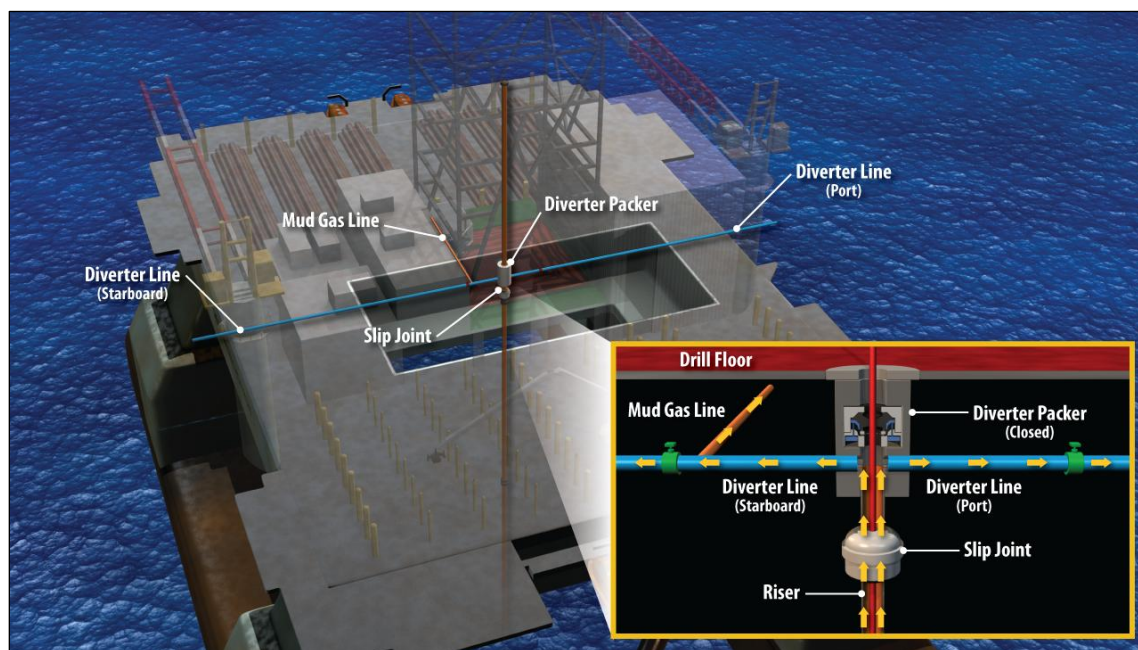
Figure 4.8.1. Diverter system.

On April 20, the rig crew diverted the influx to the mud gas separator rather than sending it overboard. That caused mud and gas to spray onto the rig from the derrick.

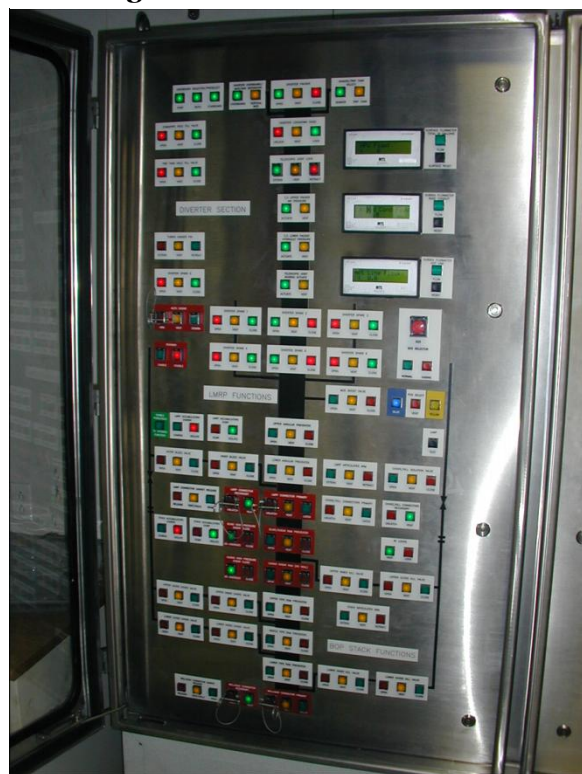
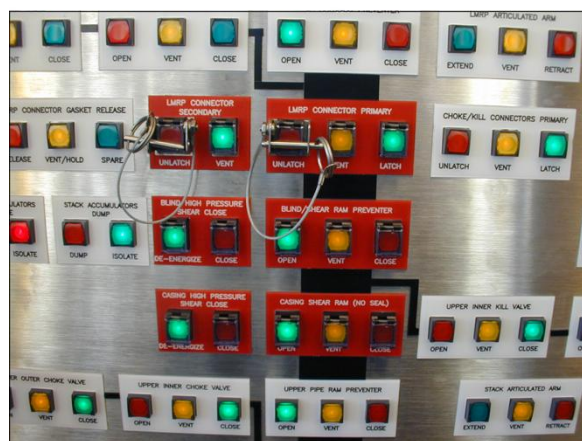
Figures 4.8.2 and 4.8.3.
BOP control panels on the rig floor
and bridge.

In addition to activating the annular preventers or pipe rams, the crew could have activated the blind shear ram to cut the drill pipe and shut in the well.⁵⁴ The blind shear ram can be activated directly by the rig crew from the control panels, seen in Figures 4.8.2 and 4.8.3.⁵⁵ There is no evidence the rig crew attempted to activate the blind shear ram prior to the explosion.⁵⁶

The blind shear ram can be activated from the BOP's control panels on the rig floor and bridge.

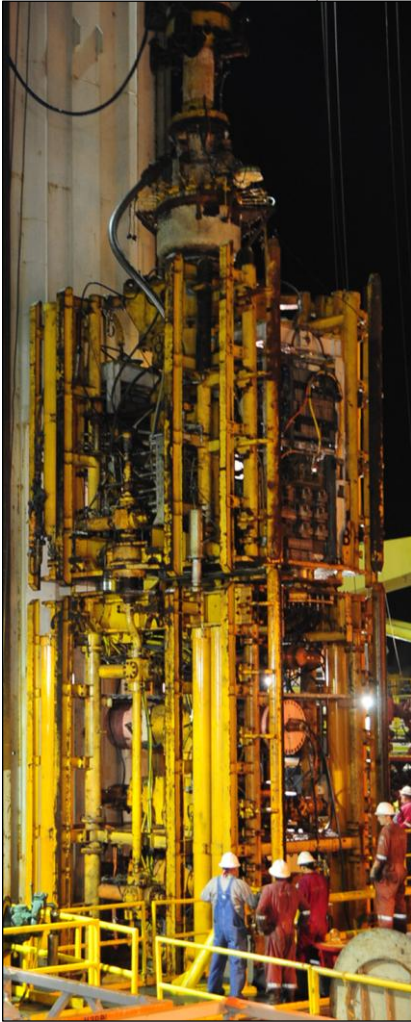
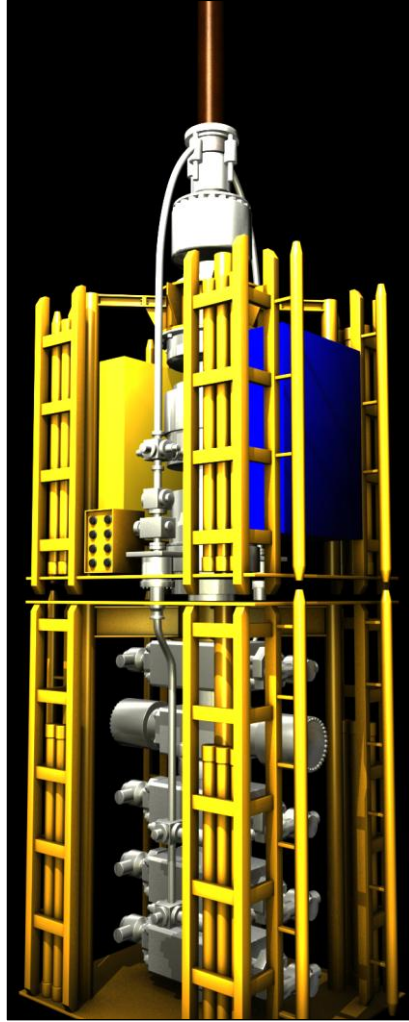
Figures 4.9.2 and 4.9.3. The *Deepwater Horizon* blowout preventer stack.

The *Deepwater Horizon*’s blowout preventer on the Mississippi River in transit to Michoud, Louisiana, to undergo forensic testing, September 11, 2010.

Left: Photo of the recovered *Deepwater Horizon* BOP. Right: 3-D model of the *Deepwater Horizon* BOP.

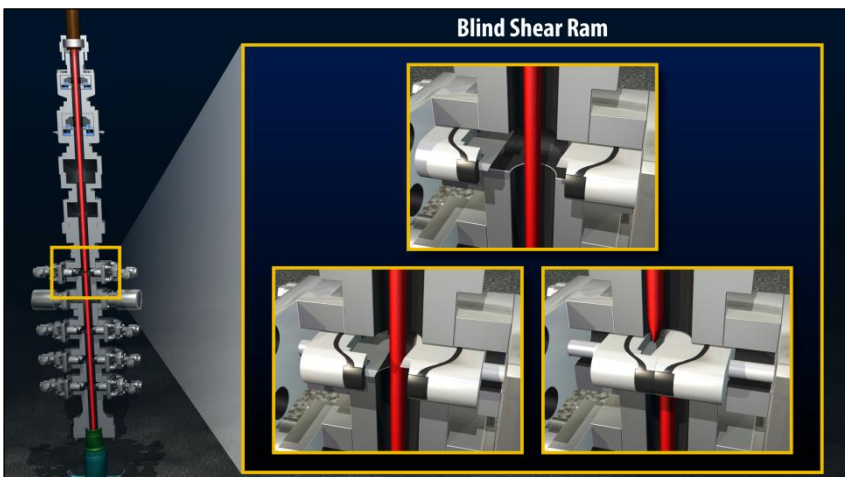
Figure 4.9.4. Blind shear ram.

Federal regulations required the *Deepwater Horizon* to have a BOP that included a **blind shear ram** (BSR).¹ The blind shear ram is designed to cut drill pipe in the well (as shown in Figure 4.9.4) and shut in the well in an emergency well control situation.* But even if properly activated, the blind shear ram may fail to seal the well because of known mechanical and design limitations. In order for a blind shear ram to shut in a well where drill pipe is across the BOP, it must be capable of shearing the drill pipe.² And blind shear rams are not always able to perform this critical function, even in controlled situations.

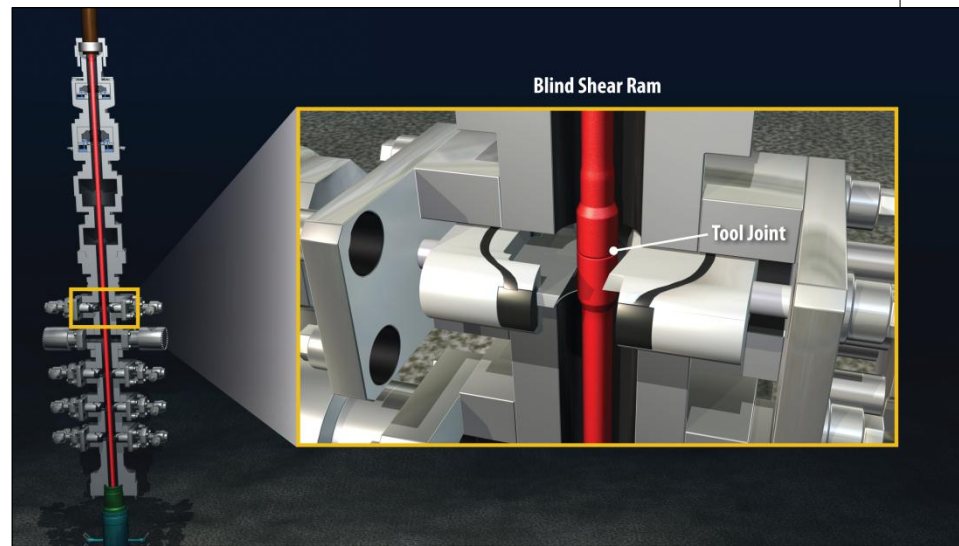
Figure 4.9.5. Tool joint in the blind shear ram.

Blind shear rams are not designed to cut through multiple pieces of drill pipe or **tool joints** connecting two sections of drill pipe.³ It is thus critically important to ensure that there is a piece of pipe, and not a joint, across the blind shear ram before it is activated.⁴ This fact prompted a 2001 MMS study to recommend every BOP to have two sets of blind shear rams such that if a tool joint prevented one ram from closing, another adjacent ram would close on drill pipe and would be able to shear the pipe and shut in the well.⁵ MMS never adopted the recommendation.

The *Horizon's* blowout preventer had only one blind shear ram. Sections of drill pipe are joined by a tool joint at each interval and are often about 30 feet in length, though some of the drill pipe used on the *Horizon* varied in length.⁶ If one of those joints was in the path of the blind shear ram at the time of attempted activation, as portrayed in Figure 4.9.5, the ram would have been unable to shear the pipe and shut in the well.

Blind shear rams cannot cut tool joints.

Even if a tool joint did not prevent the blind shear rams from shutting in the Macondo well, the inability to shear tool joints is a recognized and significant limitation. The Chief Counsel's team agrees with the MMS study that installing a second blind shear ram would mitigate this risk and increase the probability of success in shutting in a well.⁷

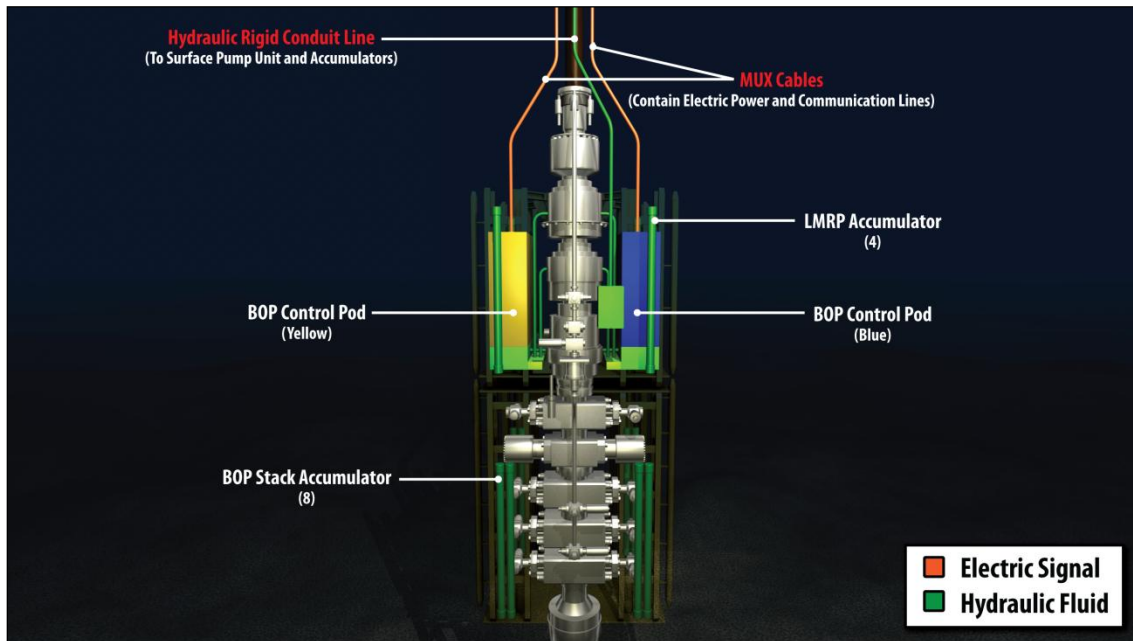
Figure 4.9.7. AMF system.

Catastrophic events on a rig can create these conditions, or emergency workers can trigger them by using an ROV to cut power, communication, and hydraulic lines to the BOP (these components are labeled in Figure 4.9.7.).⁶⁰ The AMF will not operate unless rig personnel “arm” it at a surface control panel.⁶¹ Notes from response crews and post-explosion analysis of the BOP **control pods** indicate the AMF system on the *Deepwater Horizon* BOP was likely armed.⁶²

The AMF, or deadman, system is activated in emergency conditions.

Based on available information, it appears likely that the explosion on April 20 created the conditions necessary to activate the deadman system. The multiplex (MUX) cables, which carried the power and communication lines, were located near a primary explosion **site in the rig's moon pool** and would probably have been severed by the explosion.⁶³ The hydraulic conduit line was made of steel⁶⁴ and less vulnerable to explosion damage.⁶⁵ However, the BOP would have likely lost hydraulic power at least by April 22 when the rig sank, and the deadman should thus have activated by that date.⁶⁶ Response crew personnel also tried to activate the deadman on April 22 by cutting electrical wires using an ROV.⁶⁷ According to Transocean, the AMF activated the blind shear ram.⁶⁸

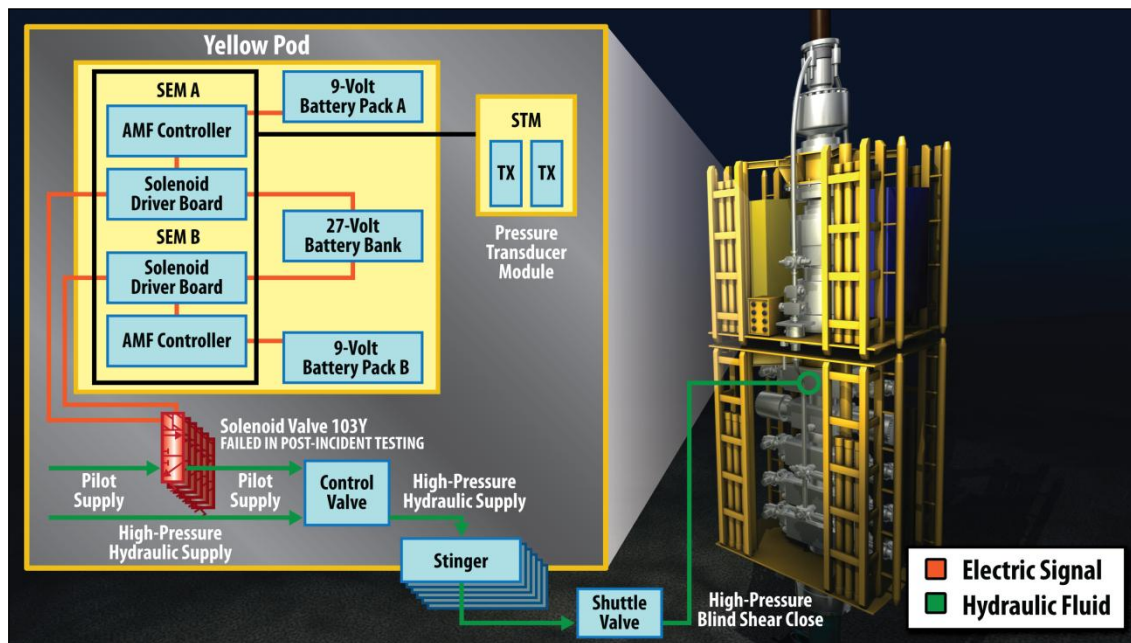
Figure 4.9.8. BOP's electrical schematic.

Control pods also rely on functioning solenoid valves (diagrammed in Figure 4.9.8). The solenoid valves open and close in response to electrical signals and thereby send hydraulic pilot signals from the pods to the BOP elements.⁸⁹ The pilot signals in turn open hydraulic valves, which then deliver pressurized hydraulic fluid into BOP rams to close them.⁹⁰ Each solenoid activates when electric signals energize one of two redundant coils in the solenoid.⁹¹

Tests on the *Deepwater Horizon*'s yellow pod revealed that the solenoid valve used to close the blind shear ram was inoperable.

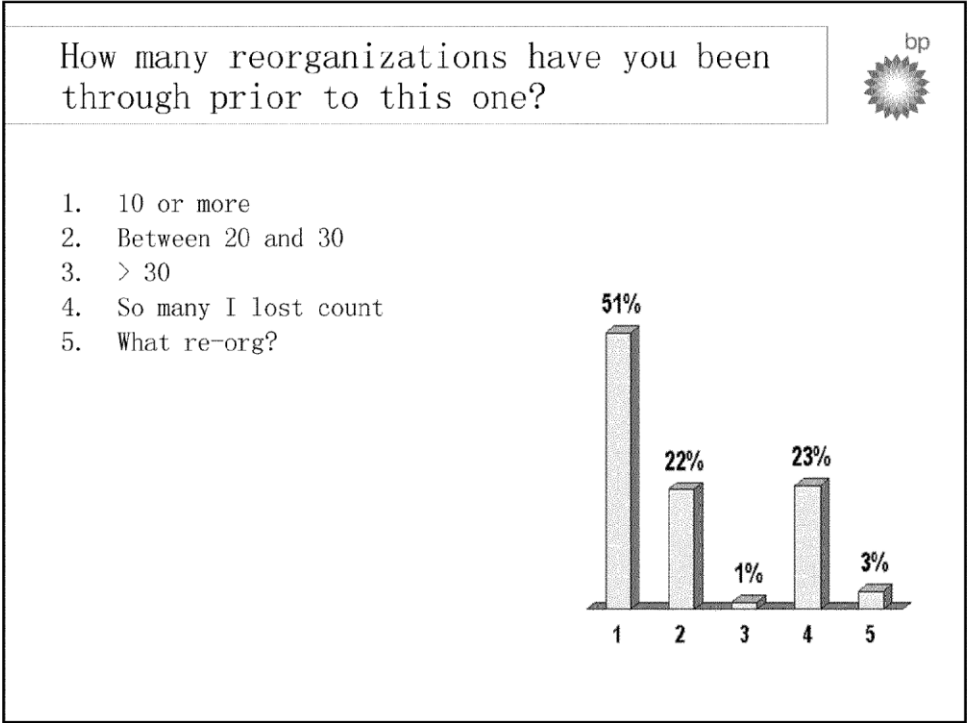
Figure 5.1. BP internal presentation slide.

The reorganization caused delays and distractions. Shortly before the reorganization, BP vice president of drilling and completions Pat O’Bryan questioned Gulf of Mexico managers about recent subpar performance, asking, “What’s getting in the way...reorg uncertainty?”¹¹ Sims later shared that there were “challenges” associated with the reorganization and that “it may have taken a little more time to ensure that there was alignment between Ops and Engineering teams.”¹² In an interview with Commission staff, Sims acknowledged that Walz may have been taking longer than usual to make engineering decisions as he came up to speed in his new role.¹³
